WP 1.3 Innovative concepts and designs for resilient S&Cs

Madrid – 21st – 22nd September 2017

Elin Söderström/Arne Nissen
Trafikverket

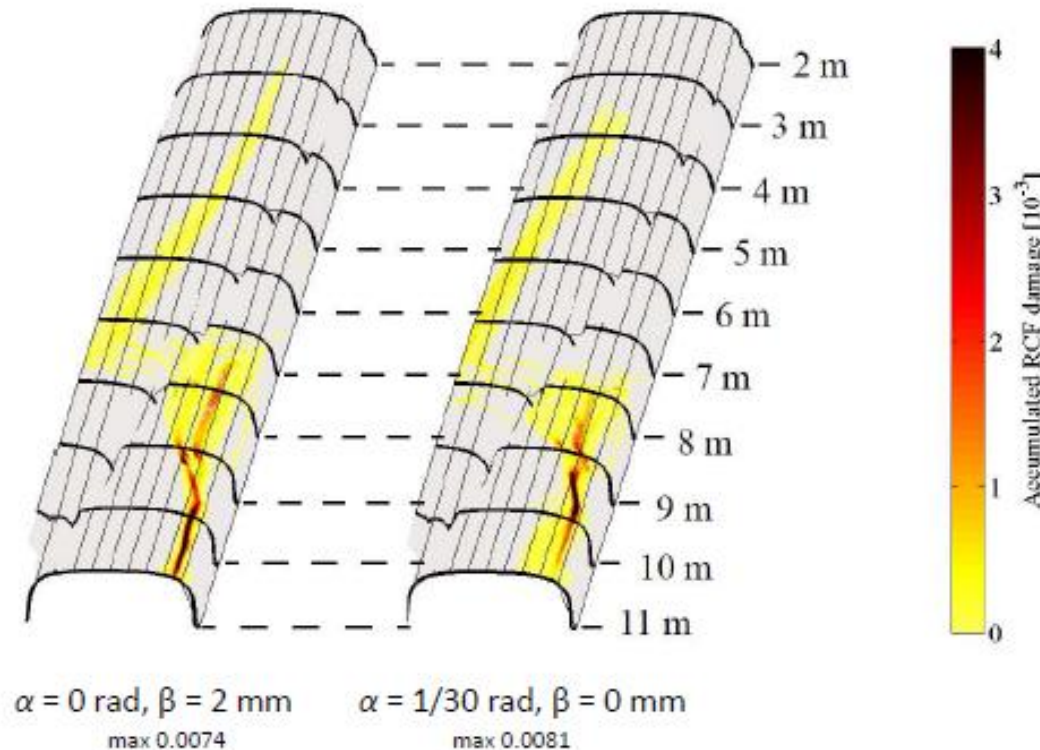
Rail profile optimisation

Output

– Cumulative contact band and cumulative damage estimates for:

- Wear
- RCF

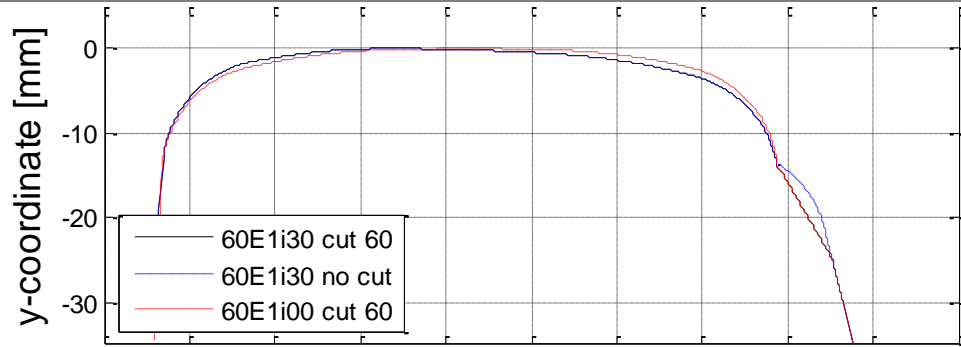
T_γ – Energy function for RCF initiation

Diverging route, facing move, 70 km/h, $\mu = 0.3$

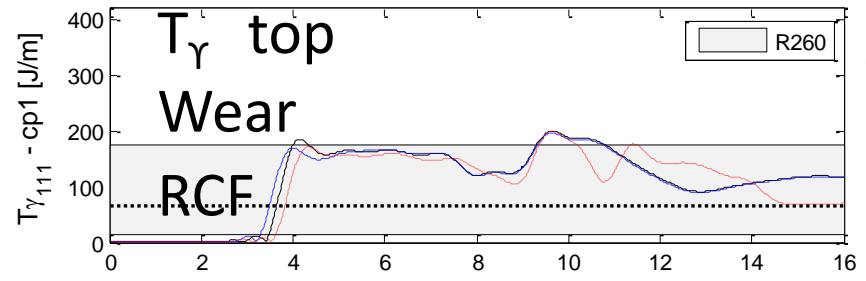
Diverging route, facing move, 70 km/h, $\mu = 0.3$

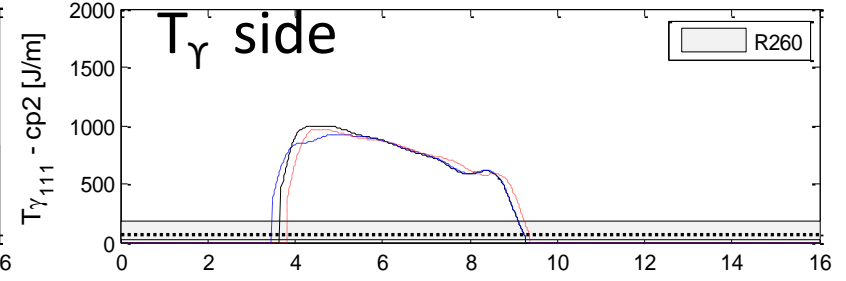
Positive coordinate towards track centre

Contact point top

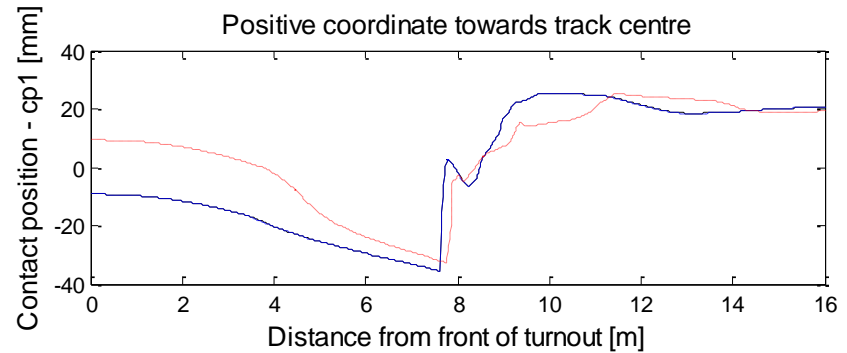
Positive coordinate towards track centre

Contact point side

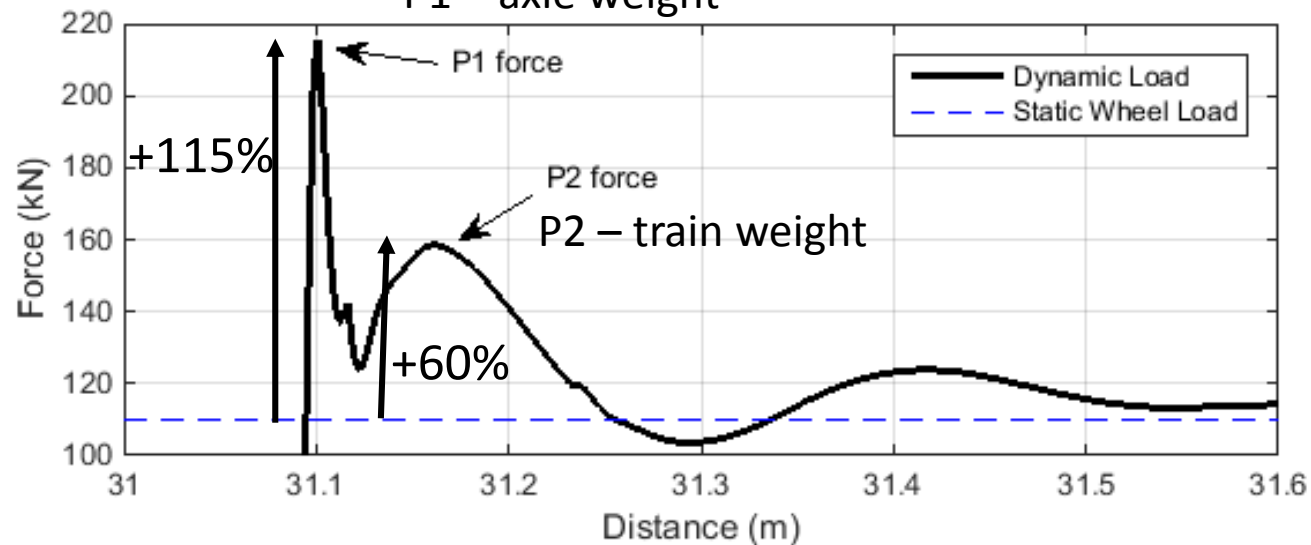
P1 – axle weight

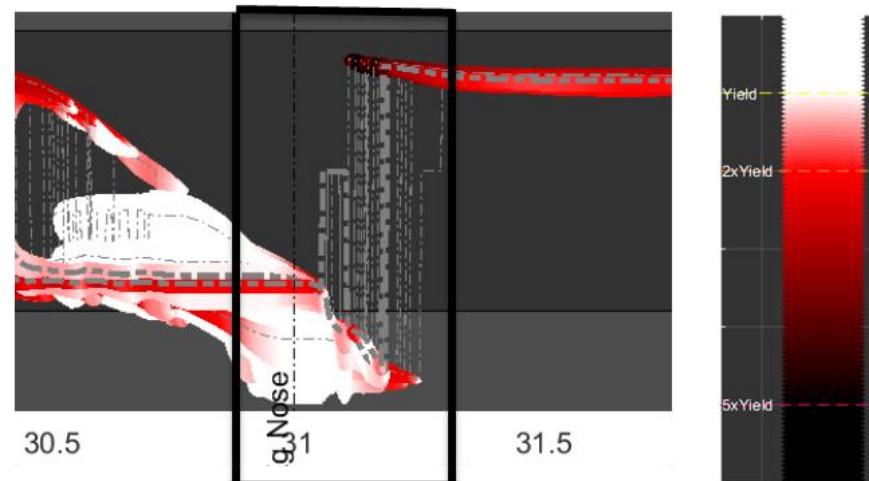
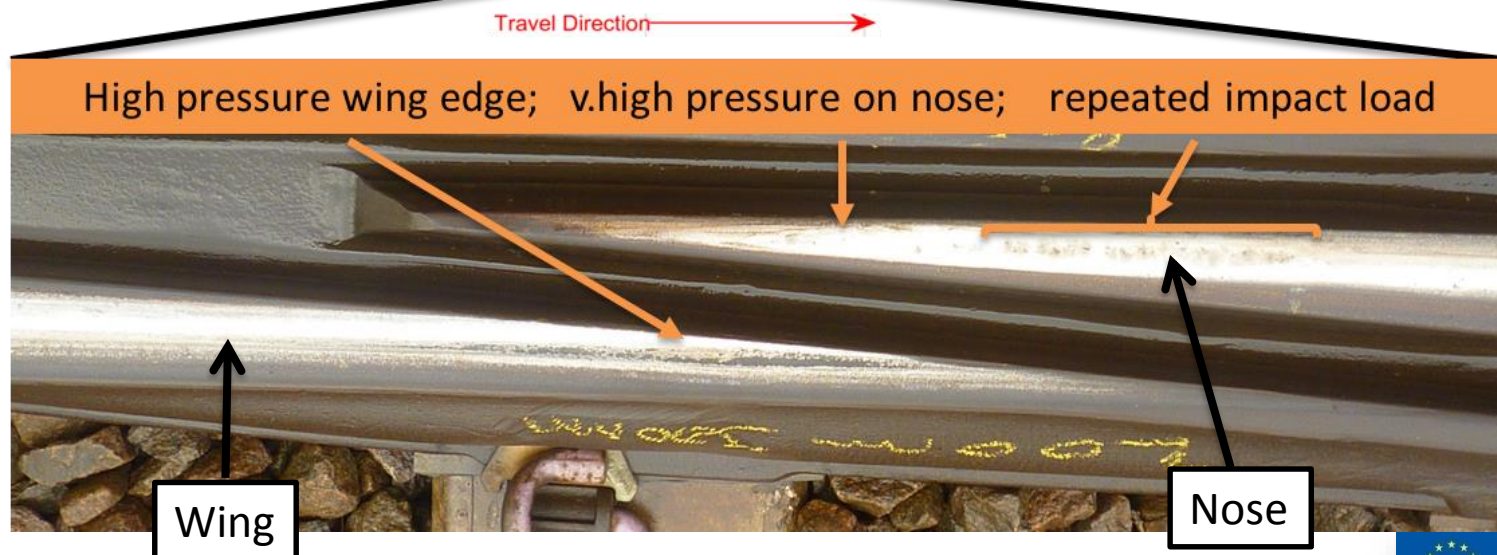
Cumulative contact band viewed from the top – crossing rails

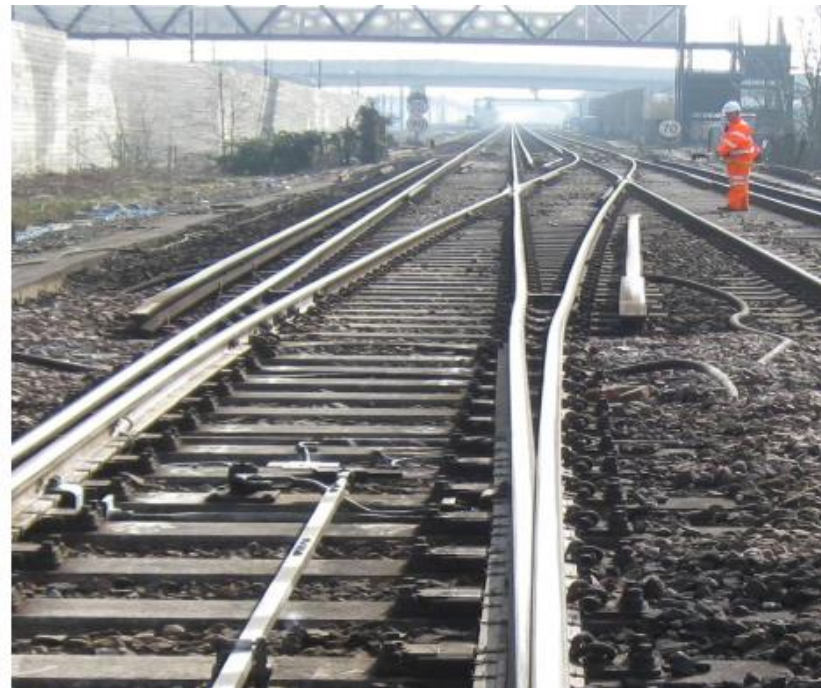
Buckling within S&C

Caused by:

- Extreme positive temperature gradients - rail expansion
- Insufficient lateral resistance

Longitudinal stresses give increased probability of buckling and will also affect the longitudinal position of the switch blade

Inside the S&C some forces also comes from diverging track

Preventative measure:

- Proper stress compensation done at assembly and welding.
- Stress redistribution after the S&C is set in operation (according to the real temperature range in the rail)

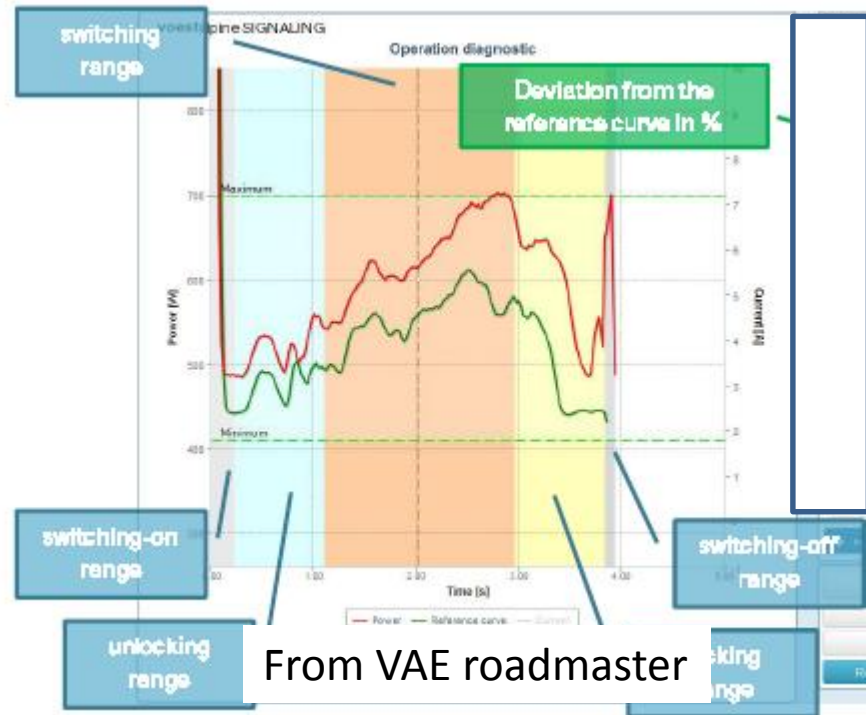
Fixed installations

Switch blade movement

Dynamic forces
