Capacity for Rail

Operational failure modes of Switches and Crossings

Public deliverable D 1.3.1

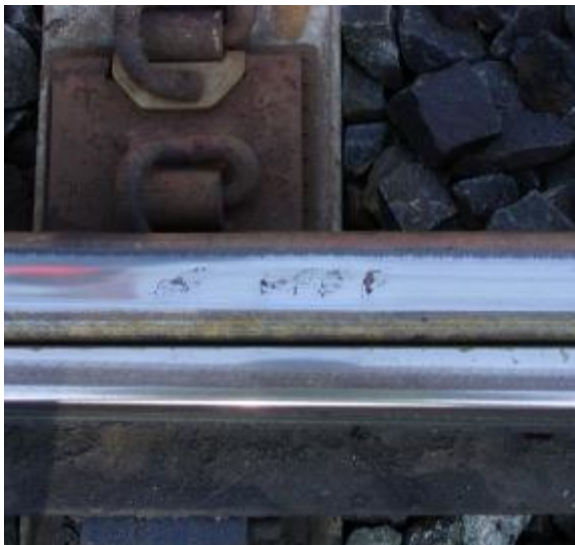
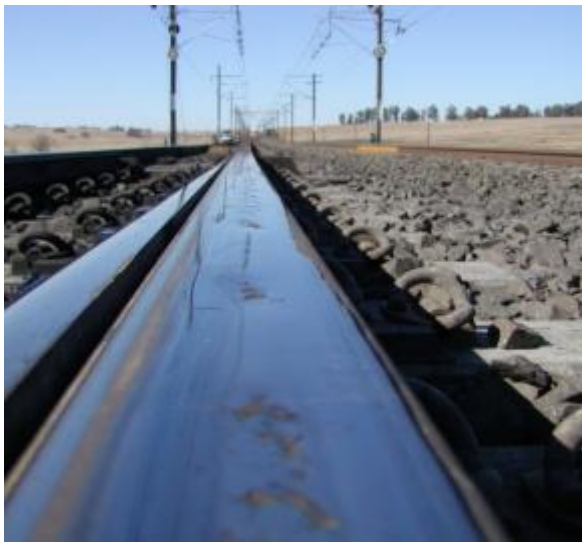
No. and Failure	Component
1.1.1 SPALLING OF STOCK RAIL	Stock rail
Characteristics	
<p>This defect mainly occurs in the wheel transfer area of the switch/stock rail and shows cavities left by material having spalled out.</p>	
<div style="display: flex; justify-content: space-around;">

</div>	
Cause	
<ul style="list-style-type: none"> • High contact stresses leading to near surface crack initiation and subsequent merger to cause spalling. High stress can result from worn wheels (false flange) or non-optimal wheel transfer zone and narrow running bands. • Wheel flange not matching together with design of wheel transfer zone • Incorrect profile of wheel flange 	
Appearance	
<ul style="list-style-type: none"> • In the wheel transfer area of the switch/stock rail 	
Corrective/Preventative Measures	
<ul style="list-style-type: none"> • Deburring • Grinding • Replacement of switch and stock rail assembly • (improved wheel profile management)

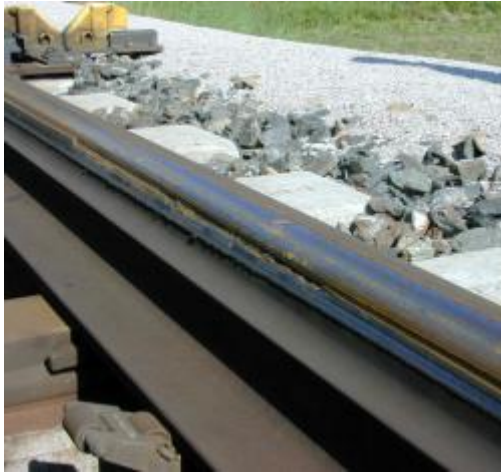
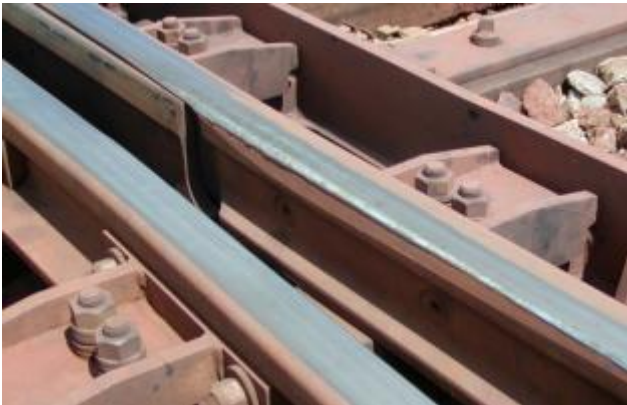
No. and Failure	Component
1.1.2 LIPPING	Switch and stock rail assembly
Characteristics	
<p>This defect mainly occurs in the wheel transfer area of the switch/stock rail and crossing nose/wing rail and appears as a plastically deformed lip. This defect can lead to material breakouts from the stock and switch rail and the crossing nose.</p>	
<div style="display: flex; justify-content: space-around;">

</div>	
Possible Causes:	
<ul style="list-style-type: none"> • Non-optimal wheel rail contact leading to high stresses that exceed the yield strength of the material and result in localised plastic deformation • Wheel flange not matching together with design of wheel transfer zone • Incorrect profile of wheel flange • Poor maintenance (prevention of lip development through early deburring) 	
Appearance:	
<ul style="list-style-type: none"> • Switch and stock rail assembly • (Also moveable crossings)

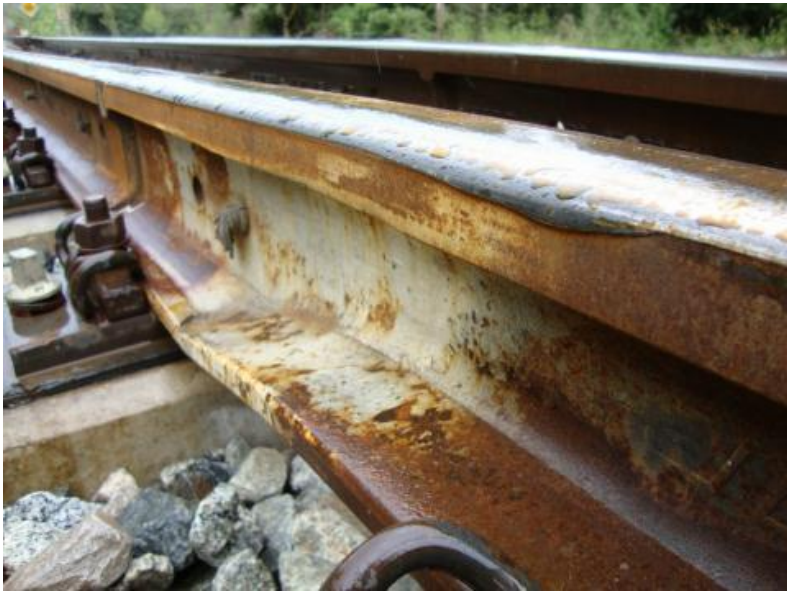
No. and Failure	Component
1.1.3 SOFT SPOTS IN THE RUNNING SURFACE	Switch Rail
Characteristics:	
<p>This defect occurs mainly in the forged area of switch rails or in close proximity of welds of fixed or moveable crossings. It is characterised by a depression in the running surface caused by localised loss of hardness and strength as a result of the heating and cooling stages during forging.</p>

Possible Causes	
<ul style="list-style-type: none"> • Incorrect heat treatment of material during forging • Incorrect welding procedure involving high preheat 	
Appearance	
<ul style="list-style-type: none"> • Switch Rail (also fixed crossing and moveable crossings) 	
Corrective/Preventative Measures:	
<ul style="list-style-type: none"> • Replacement of switch rail (resp. crossing) 	
Failure detection	
<ul style="list-style-type: none"> • by visual inspection

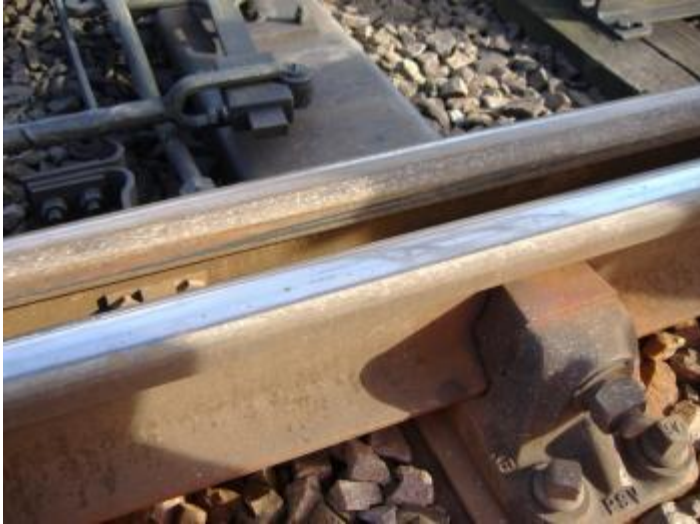
No. and Failure	Component
<p>1.1.4 NON-COMPLIANCE OF NARROWEST FLANGEWAY (RESIDUAL SWITCH OPENING)</p>	<p>Switch & stock rail assembly</p>
Characteristics	
<p>Going below the limit of the narrowest flangeway can cause a touching of the switch rail by the wheel flange during passage of the vehicles. This defect can lead to whipping of the switch rail and hence (in worst case) to a break of the switch rail.</p>

Possible Causes	
<ul style="list-style-type: none"> • Incorrect adjustment of the driving and locking device • Inadequate maintenance 	
Appearance	
<ul style="list-style-type: none"> • Switch & stock rail assembly 	
Corrective/Preventative Measures:	
<ul style="list-style-type: none"> • Correct adjustment of DLD system (if more than one DLD) • Regular inspection & maintenance 	
Failure detection	
<ul style="list-style-type: none"> • by measurement of the narrowest flange way

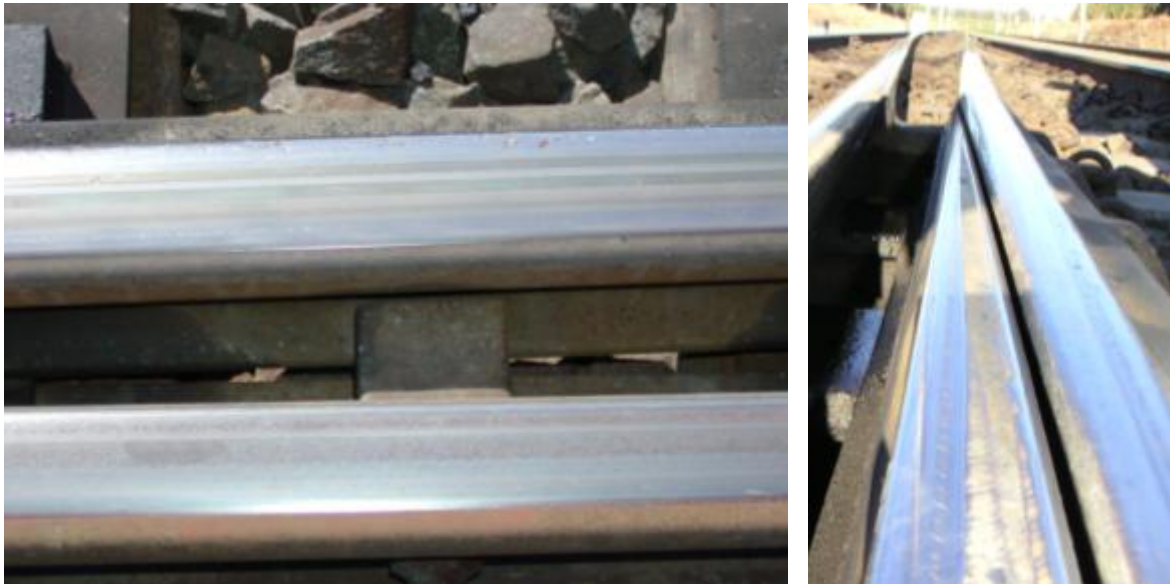
No. and Failure	Component
1.1.5 INCORRECT LATERAL ATTACHMENT OF SWITCH RAIL	Switch & stock rail assembly
Characteristics	
<p>This defect is characterised by a small gap (incorrect lateral attachment) between switch and stock rail and respectively between the crossing nose and wing rail. The defect can cause high dynamic loads that lead to accelerated damage of S & C components.</p>

Possible Causes:	
<ul style="list-style-type: none"> • Incorrect adjustment of the driving and locking device • Incorrect application of distance blocks • Excessive lipping/burr on rails • Incorrect switch rail straightening process 	
Appearance:	
<ul style="list-style-type: none"> • Switch & stock rail assembly 	
Corrective/Preventative Measures:	
<ul style="list-style-type: none"> • Correct adjustment of DLD system (Driving and locking device) • Correct adaptation of distance blocks • Deburring of rails 	
Failure detection:

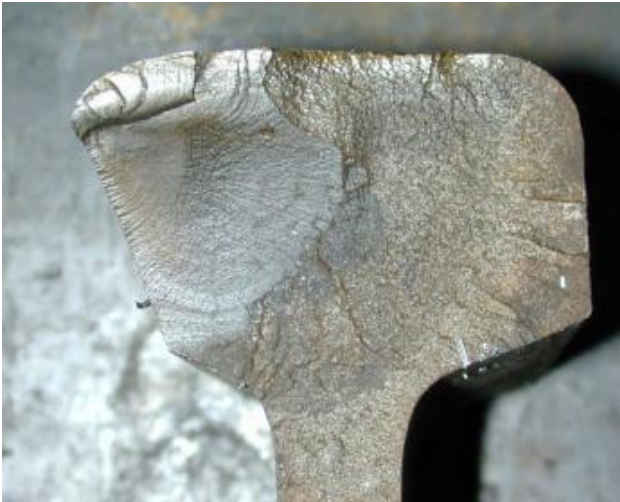
No. and Failure	Component
1.2.1 PROGRESSIVE TRANSVERSE CRACKING	All rails in a S&C
Characteristics	
<p>This defect develops from a defect inside the rail head, from an internal horizontal crack or from deep shelling of the gauge corner (very unlikely). The appellation “kidney-shaped” is explained by the characteristic shape of this progressive crack. This serious defect can occur repeatedly in the same rail and result in large gaps in the event of multiple breaks (risk of derailment).</p>

Possible Causes	
<ul style="list-style-type: none"> • Rail manufacturing defect (mainly appears on older rails manufactured by ingot casting) • High Hertzian shear stresses below surface (poor contact band conditions, wheel / rail matching) • Lipping which is not removed 	
Appearance	
<ul style="list-style-type: none"> • Develops from a defect inside the rail head (non-metallic inclusions or subsurface initiation) and is not limited to a certain zone. • Can also develop from burrs/lipping from the outside.

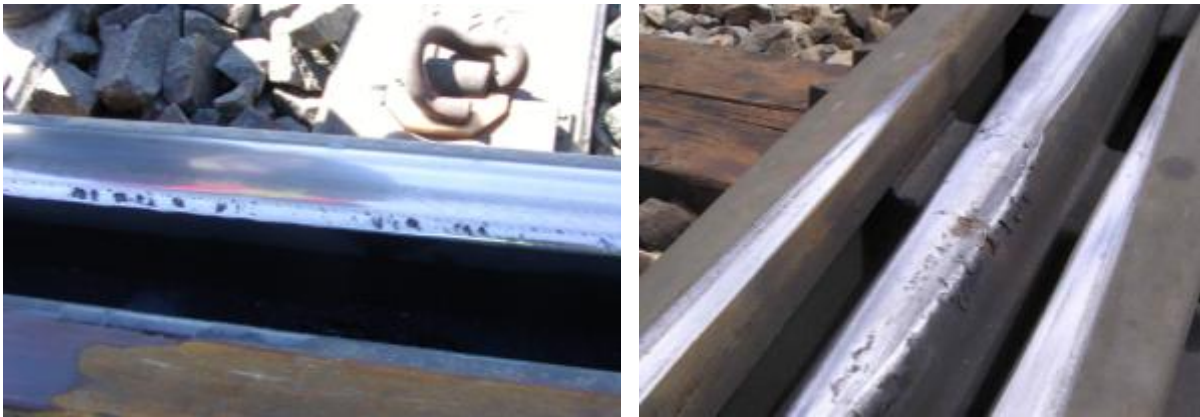
No. and Failure	Component
1.2.2 SHELLING	Rails
Characteristics	
<p><u>Shelling of the running surface:</u> This defect is characterised by the appearance of a small crack in the outer face of the rail head, a few millimetres below the running surface. At a later stage, a piece of the metal may break or peel away.</p>	
<p><u>Shelling of the gauge corner:</u> The rails first show long dark spots randomly spaced out over the gauge corner of the merger of such cracks leading to localised loss of structural integrity and peeling /shelling of the surface material in the gauge corner which can sometimes be quite extensive.</p>

Possible Causes	
<ul style="list-style-type: none"> • High contact stresses leading to sub-surface or near surface cracks that merge together to cause localised loss of structural integrity that results in spalling/shelling of the material. • Cracks due to Rolling Contact Fatigue (RCF), which are not removed before they merge. • Previous weld repair was executed incorrectly. • Crossings: High dynamic forces, lack of maintenance (grinding)

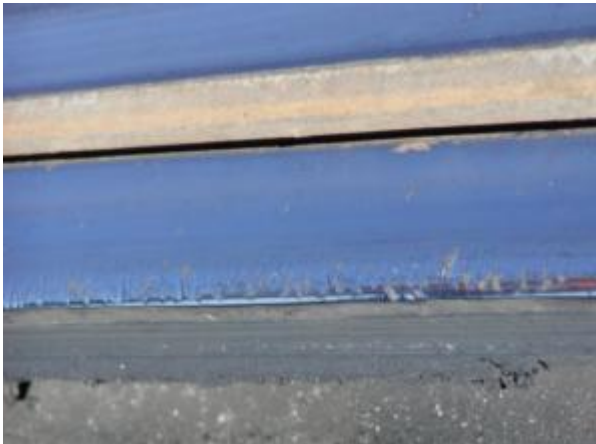
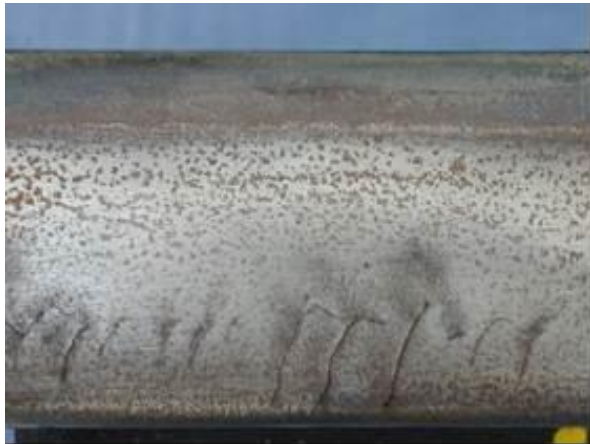
No. and Failure	Component
1.2.3 HEAD CHECKS	All rails in a S&C
Characteristics:	
<p>This typical RCF defect is characterised by small parallel cracks at the gauge corner. The distance between cracks varies depending on local conditions and the rail steel grade (normally smaller distances on head hardened rails). Depending on the wheel/rail contact condition the cracks are located with an angle of 35° to 70° (up to 90° for high traction) with reference to the longitudinal rail axis. In a first stage the cracks inside the rail head progress according to an angle of 10° to 15° and then they propagate in parallel to the running surface a few millimetres underneath the surface and end up again in the gauge corner where they may generate shelling/spalling. In certain cases the cracks grow transversally and may lead to a rail fracture.</p>	
<div style="display: flex; justify-content: space-around;">

Possible Causes:	
<ul style="list-style-type: none"> • Rolling Contact Fatigue caused by poor contact band conditions, wheel / rail matching or vehicle / track characteristics 	
Appearance:	
<ul style="list-style-type: none"> • Generally between 15mm to 25mm from the gauge corner of rails in a S&C and of moveable crossings 	
Corrective/Preventative Measures:	
<ul style="list-style-type: none"> • Optimised rail-wheel contact with gauge corner relief (with care to conicity and wheel/rail interface) • Optimised selection of rail steel grade for the conditions • Preventive grinding • Replacement of rail once cracks have turned down • Limits for Head Checks, before they are growing down, should be defined (safety related) 	
Failure detection:	
<ul style="list-style-type: none"> • Can be detected by visual and ultrasonic testing

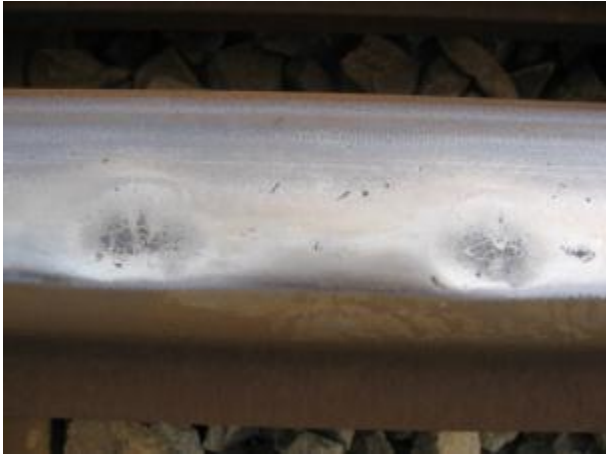
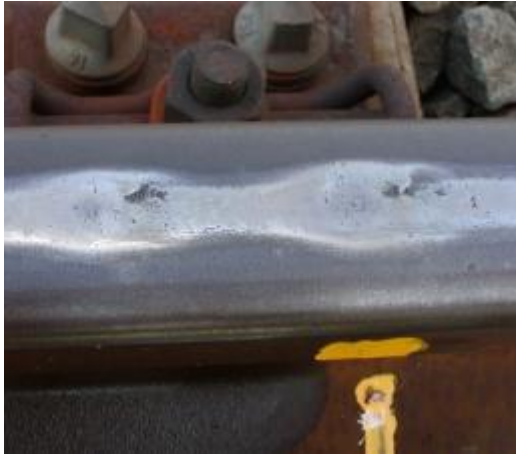
No. and Failure	Component
1.2.4 SQUATS	All rails in a S&C
Characteristics	
<p>This RCF defect is visible on the running surface as a widening and a localised depression of the rail/wheel contact band, accompanied by a dark spot containing cracks with a circular arc or V-shape. The cracks propagate inside the head, at first at a shallow angle to the surface. Then, when they reach app. 3-5mm depth, the cracks propagate transversely and can lead to a break of the rail.</p>	
<p><u>Squats on moveable crossings:</u> This defect is characterised as longitudinal cracks on the surface of moveable crossings of high speed turnouts. The cracks propagate underneath the running surface and end up in the gauge corner (can result in spalling of the running surface) (Text from DB).</p>	
<div style="display: flex; justify-content: space-around;">

</div>	
Possible Causes	
<ul style="list-style-type: none"> • Multiple theories exist about the formation of squats with little universal agreement. Potential causes include high contact stresses, localised change of microstructure caused by wheel micro slip etc

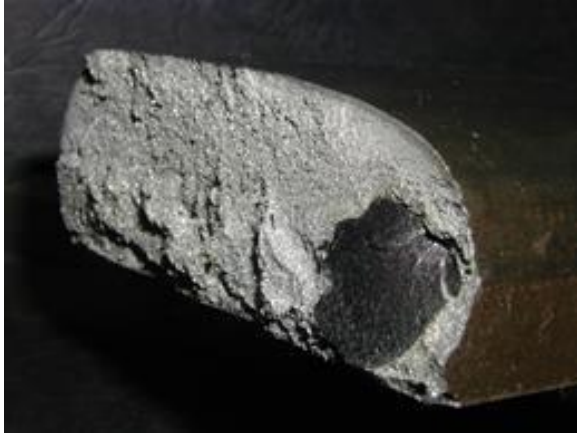
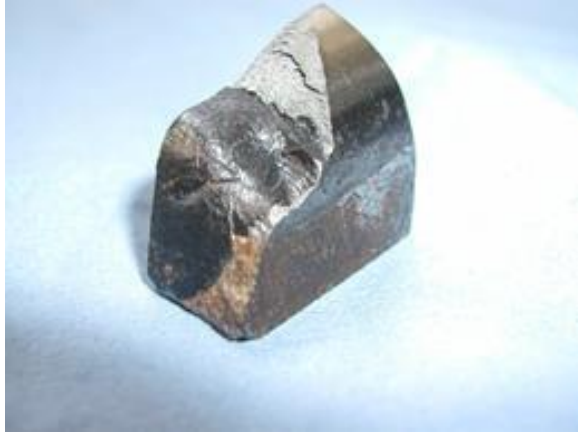
No. and Failure	Component
1.2.5 SUB-SURFACE INITIATED FATIGUE	All rails in a S&C
Characteristics	
<p>There are no visible cracks on the surface that can be detected during track walking inspection or with eddy current testing. Ultrasonic testing will pick up such defects when they have grown to a large enough size as in the case of the classic “Tache Ovale” defects</p>

Possible Causes	
<p>High Hertzian shear stresses below the running surface. Presence of oxide inclusions in old rail steels acted as stress raisers and initiated fatigue cracks that propagated and turned down to cause rapid fracture. However, sufficiently high stresses through non-optimal contact at gauge corner can cause sub-surface initiation of fatigue in modern clean steels</p>	
Appearance	
<p>Not visible at the surface but narrow running bands close to the gauge corner are indicative of the possibility of sub-surface initiated cracks</p>

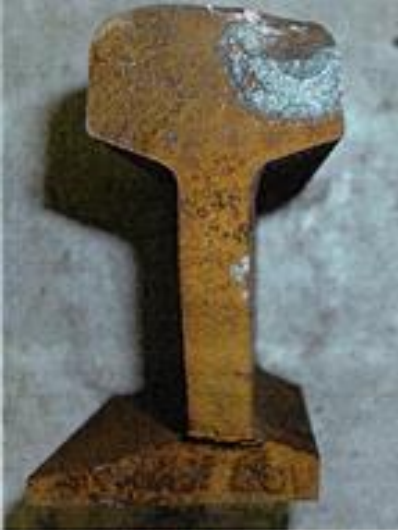
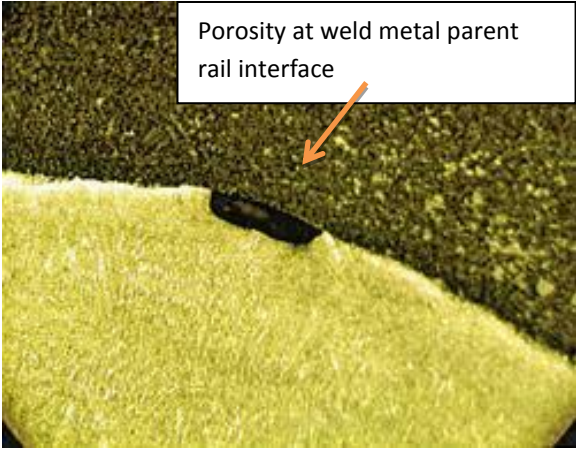
No. and Failure	Component
1.2.6 FATIGUE FROM WELD REPAIR	All rails in a S&C
Characteristics	
<p>There are no visible cracks on the surface that can be detected during track walking inspection or with eddy current testing. Evidence of MMA weld repair can sometimes be detected on the running surface and can show plastic deformation but this is not a certain indication of the presence of sub-surface fatigue. Ultrasonic testing will pick up such defects when they have grown to a large enough size as in the case of the classic “Tache Ovale” defects.</p>

Possible Causes	
<p>Presence of porosity at weld metal-parent rail interface acts as the fatigue initiation site under the high Hertzian shear stresses below the running surface. The presence of such defects is sufficient to initiate fatigue even under optimal rail-wheel contact.</p>	
Appearance	
<p>Not visible at the surface but sometimes plastic deformation of the weld repaired region can be indicative of sub-surface fatigue</p>

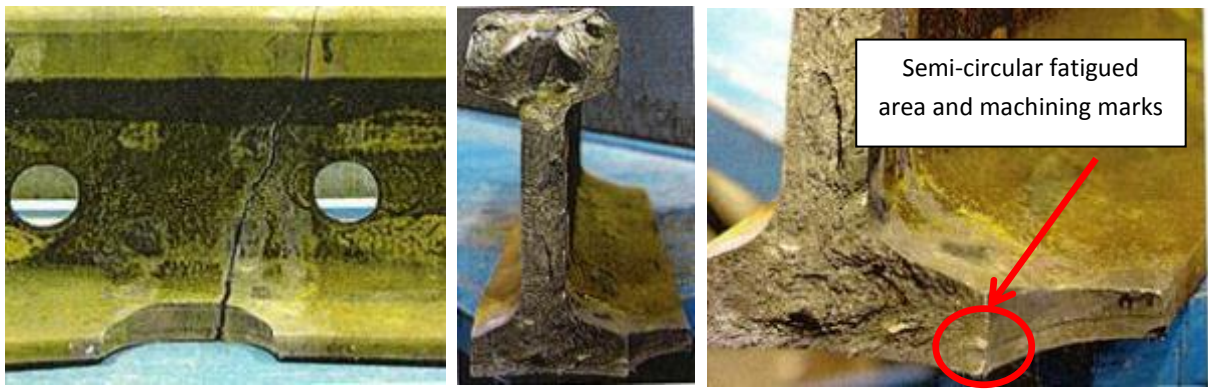
No. and Failure	Component
1.2.7 FATIGUE FROM MACHINING STRESS RAISERS	All rails in a S&C
Characteristics	
<p>Such defects do not display any visible signs on the running surface until or close to the stage of fast brittle fracture. The nature of S&C design requires machining of the rail foot region that experiences the maximum tensile stresses and consequently the initiation of fatigue from any stress raisers arising either from the designed shape or through poor machining. The fatigued area is generally small and hence they are more difficult to detect unless directly in line with ultrasonic inspection.</p>

Possible Causes	
<p>The foot of the rail experiences the maximum tensile stresses from the applied vehicle load and the presence of stress raisers, such as sharp machining marks, is sufficient to initiate fatigue. The critical defect size for fast fracture for the rail steels in use is quite small and hence the small fatigued area before brittle fracture of the whole section.</p>

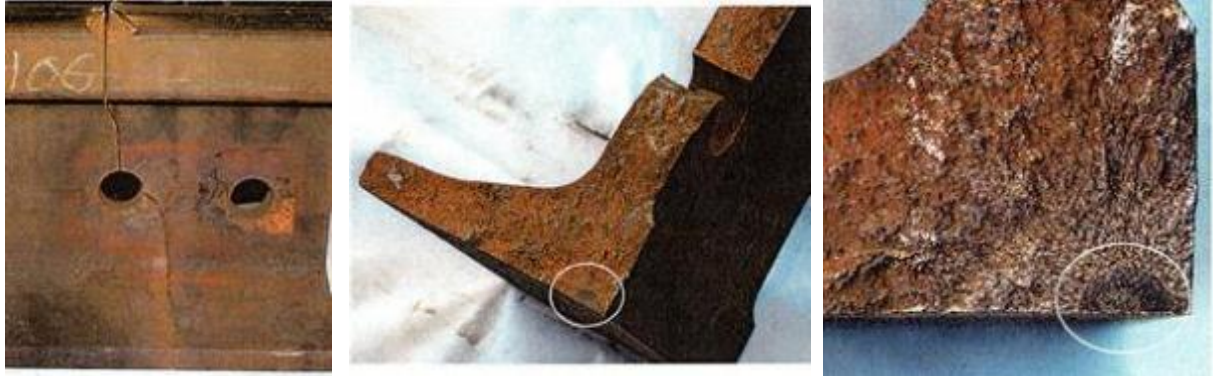
No. and Failure	Component
1.2.8 TRANSVERSE FRACTURE FROM CORROSION PIT	All rails in a S&C
Characteristics	
<p>Corrosion on the base of the foot can have tiny sharp cracks that provide the site for fatigue initiation. They grow to a critical size under the cyclic loading but because of the outer fibre stresses experienced by the rail and the fracture toughness of the currently used pearlitic rail steel grades, fast brittle fracture results in a transverse break at a fatigued area no greater than a thumb nail.</p>

Possible Causes	
<p>Environmental conditions leading to corrosion at the base foot and leading to fatigue initiation and subsequent fracture</p>	
Appearance	
<p>It is not practical to detect such defects during manual track inspections and they can often be missed by ultrasonic inspection car depending on the location and size of the fatigued area, Such failures can occur anywhere on the network and do not necessarily require very corrosive environment.</p>

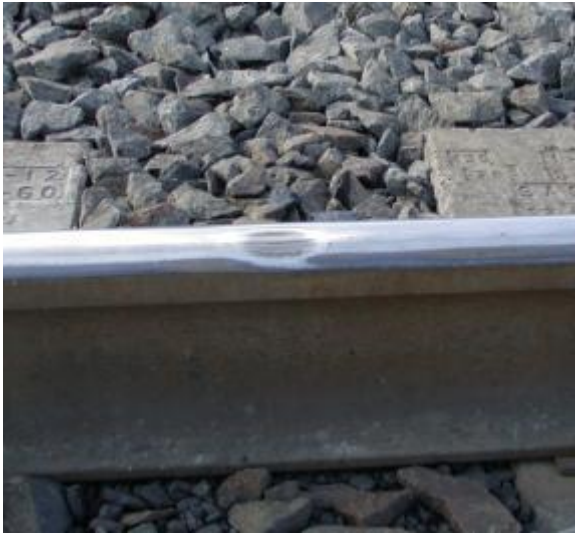
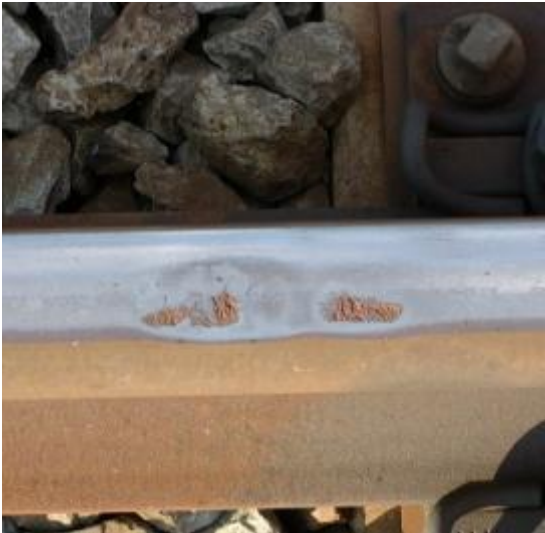
No. and Failure	Component
1.2.9 WHEEL BURN	All rails in a S&C
Characteristics	
<p>The slipping of a driving axle can cause an elliptical-shaped-self-hardened layer. This layer may disappear or develop - either horizontally where it soon degenerates into shelling or transversally in the head resulting in an internal crack which can lead to a break. Wheel burn defects are present on both rails of the track. A wheel burn can turn into a squat-type defect if not removed.</p>	
<div style="display: flex; justify-content: space-around;">

</div>	
Possible Causes	
<p>Consequence of slipping of wheels on the rail during braking or accelerating giving rise to localised increase in temperature to very high levels that transforms the microstructure and characteristics of the rail steel.</p>	
Appearance	
<ul style="list-style-type: none"> • On the running surface (of both rails) within the running band •

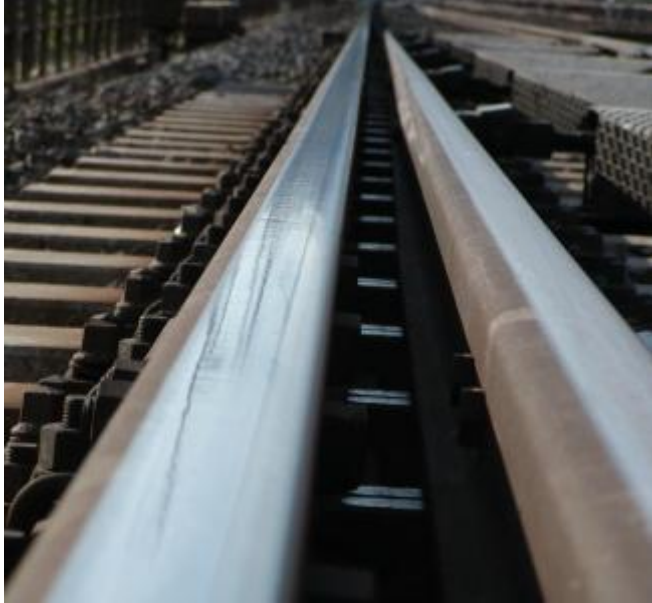
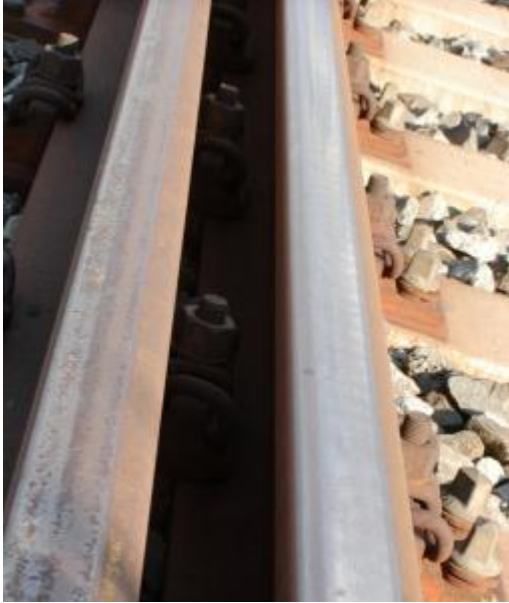
No. and Failure	Component
1.2.10 SHORT-PITCH CORRUGATION	All rails in a S&C
Characteristics	
<p>Short pitch corrugation is characterised by a pseudo periodical sequence of bright ridges and dark hollows on the running surface. The pitch generally varies between 20 and 100mm with a depth of 0,01 to 0,4mm.</p>	
<div style="display: flex; justify-content: space-around;">

</div>	
Possible Causes	
<p>There is no universal consensus on the cause of short pitch corrugations, although it is generally accepted that it entails the combined effects of wear and plastic deformation. The contribution of discrete irregularities capable of excitation of the passing vehicle is also generally accepted.</p>	
Appearance	
<p>On the running surface (can occur on straight track) in curves with large radii or on low rail in small radii curves)</p>	
Corrective/Preventative Measures	
<ul style="list-style-type: none"> • Grinding • Use of harder steel grades

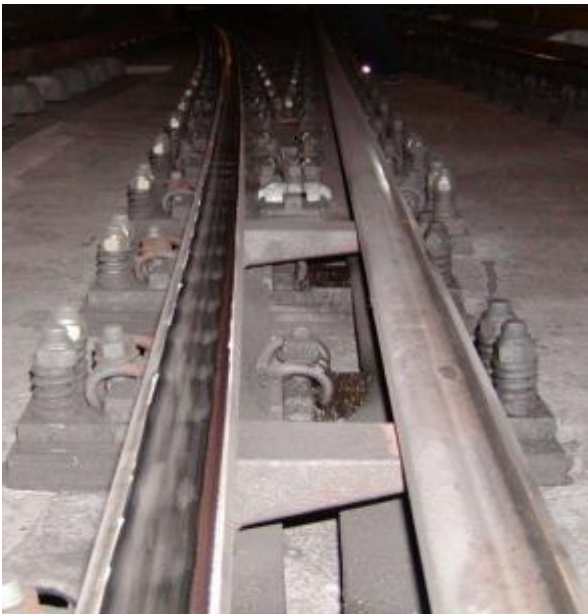
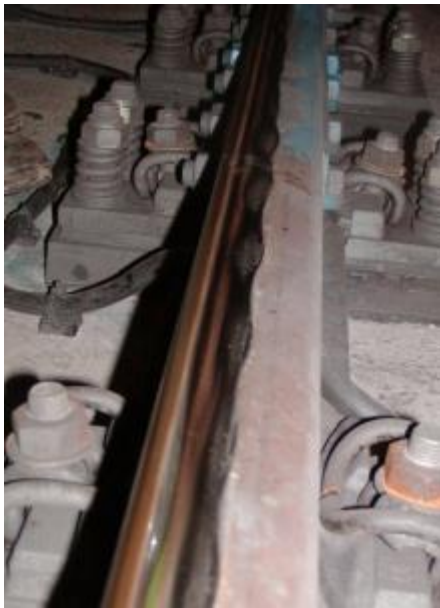
No. and Failure	Component
1.2.11 LONG-PITCH CORRUGATION	All rails in a S&C
Characteristics	
<p>Long pitch corrugation (“waves”) is characterised by depressions in the running surface. The pitch generally varies between 30 and 300mm with a depth up to 1mm. With this type of corrugation, there is no difference in appearance between ridges and hollows.</p>	
<div style="display: flex; justify-content: space-around;">

</div>	
Possible Causes	
<ul style="list-style-type: none"> • No universal agreement on the root cause but (slipping of wheel is often cited as a key cause.) 	
Appearance	
<ul style="list-style-type: none"> • On the running surface of the inside rail in curves with radii to 500m (partly to 800m) 	
Corrective/Preventative Measures	
<ul style="list-style-type: none"> • Grinding • Use of harder steel grades 	
Failure detection	
<ul style="list-style-type: none"> • by visual inspection • by acoustic inspection • by acceleration measurements

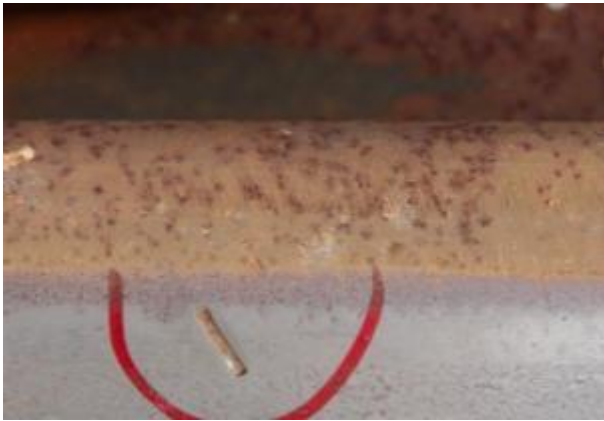
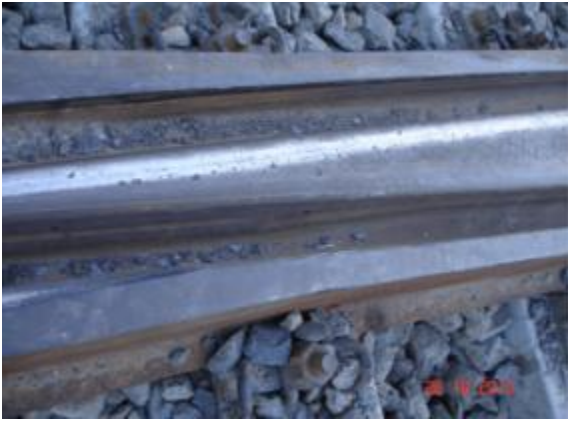
No. and Failure	Component
1.2.12 IMPRINTS	All rails in a S&C
Characteristics	
<p>This defect mainly occurs at regular intervals on several consecutive rails, sometimes over a considerable distance. When the imprint has a sharp profile, it can have a notch effect which can lead to cracks and finally in worst case to rail breaks.</p>	
<div style="display: flex; justify-content: space-around;">

</div>	
Possible Causes	
<ul style="list-style-type: none"> • Defect due to damaged wheels • Ballast imprints • Foreign obstacles 	
Appearance	
<ul style="list-style-type: none"> • Periodically (depending on wheel size) on consecutive rails or randomly both rail lines 	
Corrective/Preventative Measures	
<ul style="list-style-type: none"> • Spot repair (grinding, repair welding) • Replacement of rail 	
Failure detection	
<ul style="list-style-type: none"> • by visual inspection

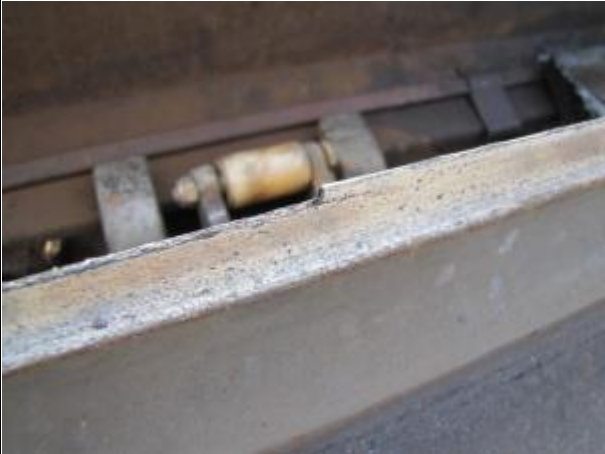
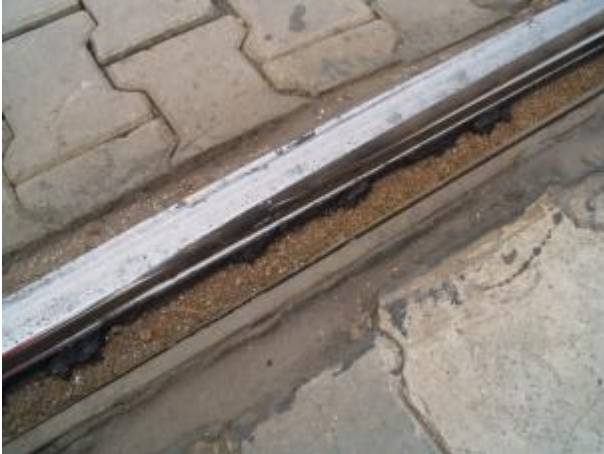
No. and Failure	Component
1.2.13 ABRASIVE WEAR	All rails in a S & C
Characteristics	
<p>This defect mainly occurs in turnouts with small radii (< 500m). It is characterised by excessive wear of the outside rail in the diverging route. Excessive lateral wear can lead to critical gauge widening or to a rail fracture caused by weakening of the profile. This can be combined with metal flow on the switch tip.</p> <p>The length and depth of such a defect should be categorized and limited to prevent derailment.</p>	
<div style="display: flex; justify-content: space-around;">

</div>	
Possible Causes	
<ul style="list-style-type: none"> • Small radii and switches mainly used in diverging route. • High tensile forces on material. 	
Appearance	
<ul style="list-style-type: none"> • Outside rail in the diverging route (mainly switch rail) 	
Corrective/Preventative Measures	
<ul style="list-style-type: none"> • Keeping rail under observation, measuring wear • Using of appropriate rail material (head special hardened) • Replacement of rail. Grinding of metal flow.

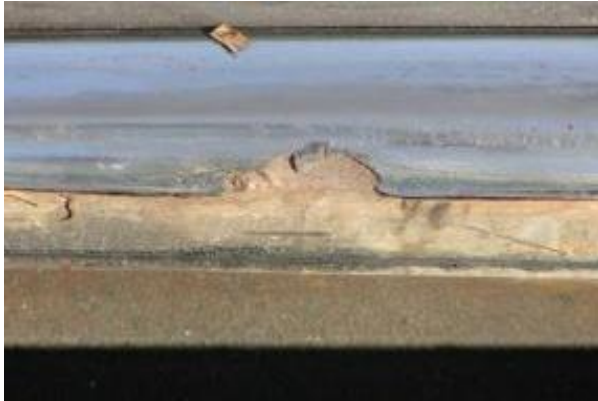
No. and Failure	Component
1.3.9 PLASTIC DEFORMATION OF THE CROSSING NOSE	Crossing nose of moveable crossing
Characteristics	
<p>This defect is characterised by a depression in the running surface and lateral metal flow and subsequently burr on the crossing nose. This defect can lead to material breakouts of the running surface.</p> <div style="text-align: center;">

</div>	
Possible Causes	
<ul style="list-style-type: none"> • Non optimal rail-wheel contact in the wheel transfer zone that leads to increased lateral forces and the high resulting stresses that are above the yield strength of the material • Wheel flange not matching together with design of wheel transfer zone • Incorrect profile of wheel flange. Inadequate control of wheel profile 	
Appearance	
<ul style="list-style-type: none"> • On crossing noses in the zone of the wheel transfer 	
Corrective/Preventative Measures:	
<ul style="list-style-type: none"> • Deburring • Resurfacing by build-up welding (if necessary) • (correcting of wheel profile)

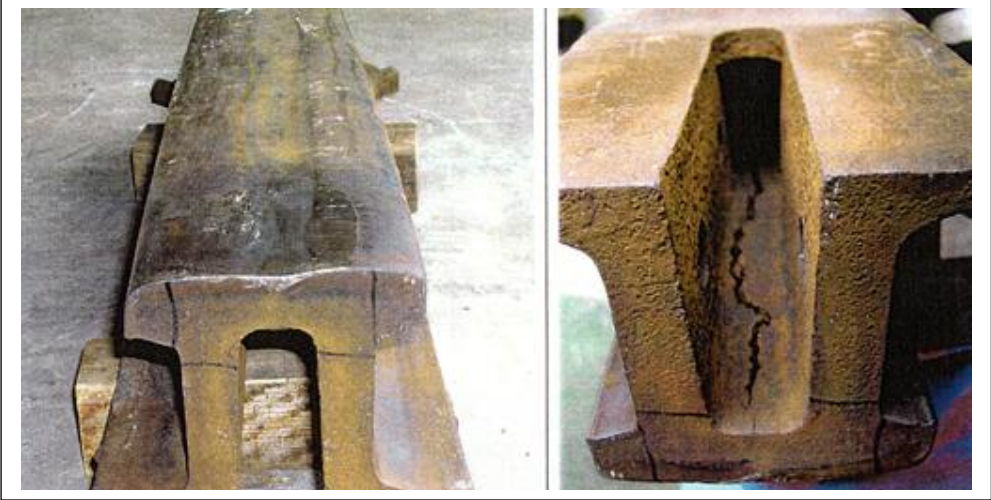
No. and Failure	Component
1.4.4 CASTING DEFECT LEADING TO CRACKING	Cast manganese crossing
Characteristics	
<p>Casting of large objects such as a crossing presents many challenges and, at times, can result in casting defects such as shrinkage cavities and porosity. Such defects are not visible to the surface and do not have a major impact on the life of the crossing if they are deep into the body of the casting. However, as the casting wears, such defects can become stress raisers leading to spalling and or failures. The photograph shows longitudinal cracking from a shrinkage cavity.</p>

Possible Causes	
<ul style="list-style-type: none"> • Manufacturing defect (shrinkage cavities and porosity) arising from casting preparations and conditions 	
Appearance	
<p>Such defects are not visible on the running surface but as the crossing wears, the defects become closer to the running surface and under the influence of the loading conditions that can propagate spalling or failure, at which stage they can be detected through manual inspections</p>

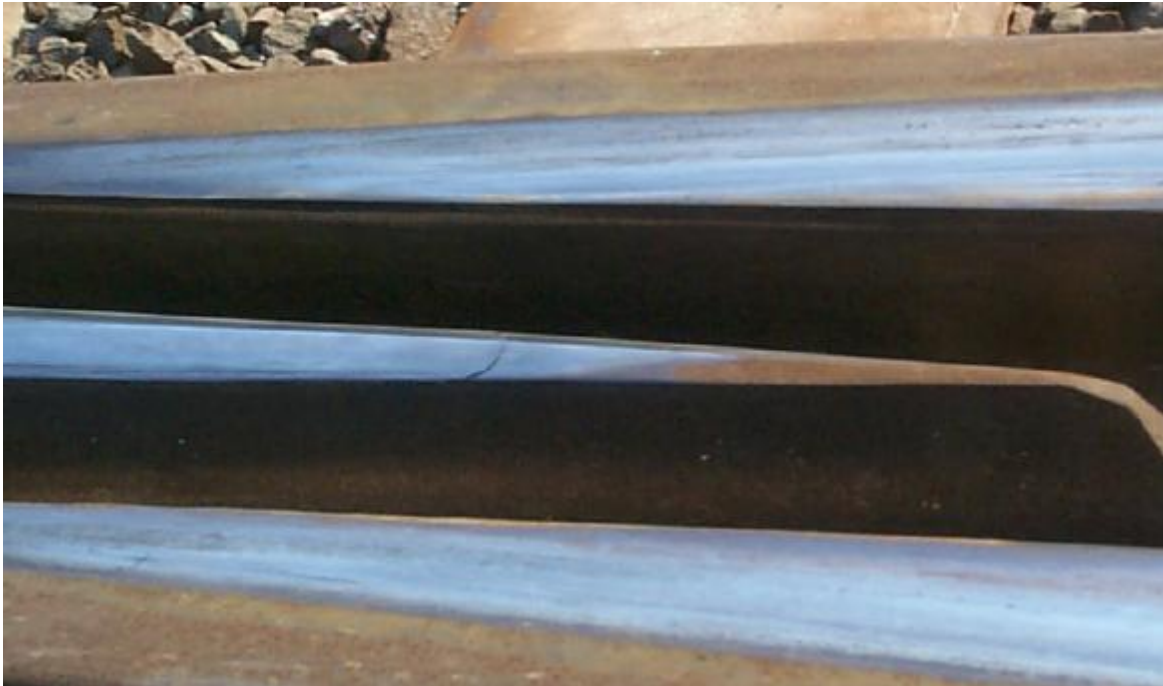
No. and Failure	Component
1.4.5 TRANSVERSE CRACK ON THE CROSSING NOSE	Cast manganese crossing
Characteristics	
This crack is located in the front area of the crossing nose.

Possible Causes	
<ul style="list-style-type: none"> • High vertical impact loading stresses on material due to wheel / crossing combination • Wheel flange not matching together with design of wheel transfer zone • Inadequate control of wheel profiles 	
Appearance	
<ul style="list-style-type: none"> • In the front area of the crossing nose (wheel transfer area). 	
Corrective/Preventative Measures	
<ul style="list-style-type: none"> • Easy to repair (Repair welding) but effectiveness could be limited when overheating of base material. 	
Failure detection	
<ul style="list-style-type: none"> • by visual inspection

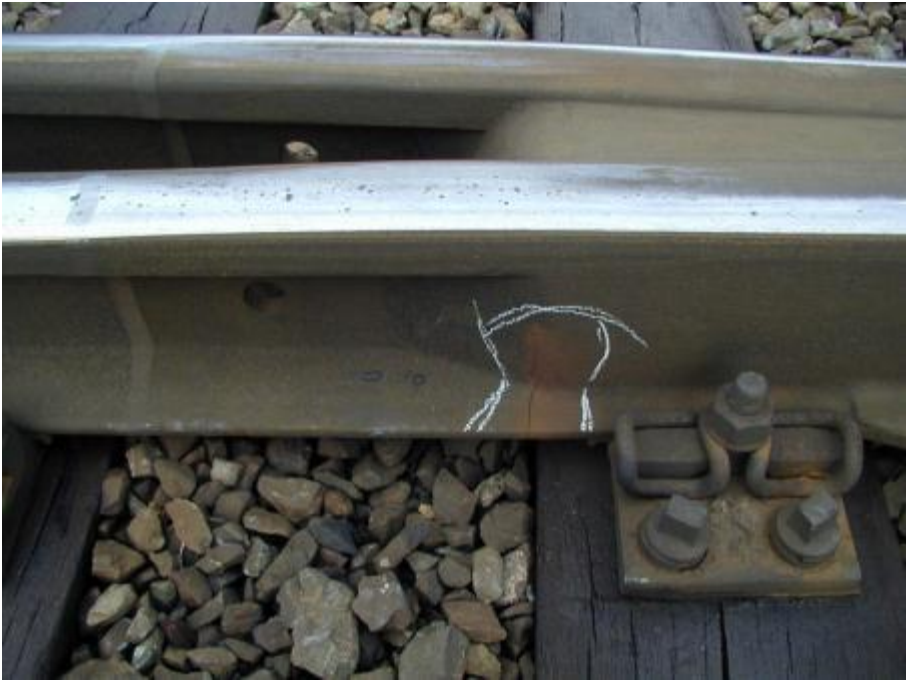
No. and Failure	Component
1.4.6 TRANSVERSE CRACK ON THE CROSSING BOTTOM	Cast manganese crossing
Characteristics	
This crack is located in the rear zone of the crossing, from the wing rail end in the area of the closure rails.

Possible Causes	
<ul style="list-style-type: none"> • High dynamic forces, poor support conditions, and mechanical damage at the base of the foot together with the stress raising effect at the edge of sleeper • Manufacturing defect (casting porosities) • 	
Appearance	
<ul style="list-style-type: none"> • In the rear zone of the crossing, from the wing rail end in the area of the closure rails (mainly at the rear change of section surface). 	
Corrective/Preventative Measures	
<ul style="list-style-type: none"> • Keeping crossing under observation • Improved support to minimise deflection in the vicinity of crack • Repair welding • Replacement of the crossing when the critical crack length is reached.

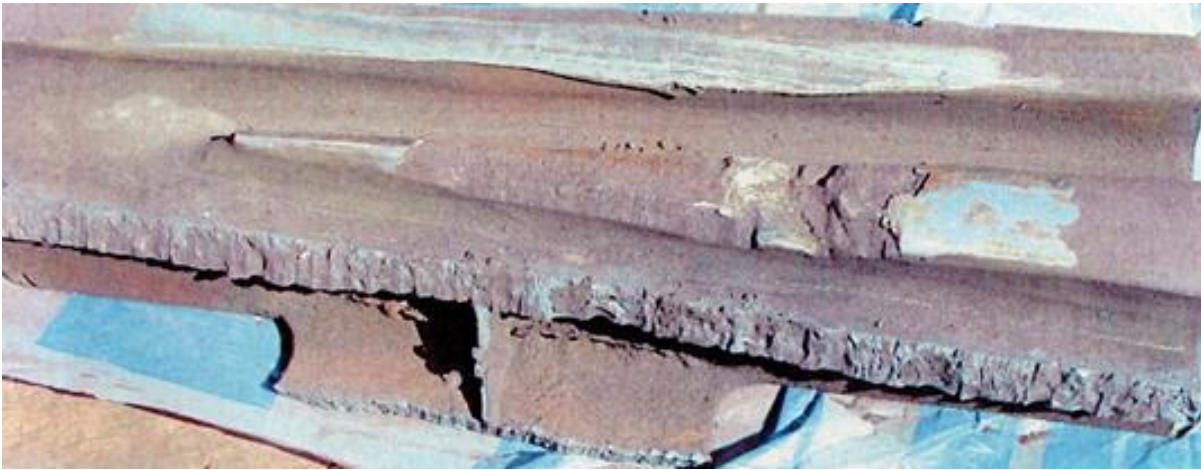
No. and Failure	Component
1.4.7 SPALLED WELD DEPOSIT	Cast manganese crossing
Characteristics	
<p>The defect may not be visible on the running surface in the early stages of development and could be growing by fatigue initiated at a weld repair defect such as porosity or slag inclusion. Evidence of MMA weld repair can sometimes be detected on the running surface and presence of high plastic deformation of the weld metal could be indicative of internal fatigue development.</p>

Possible Causes	
<p>Presence of porosity or inclusions at weld metal-parent material interface acts as the fatigue initiation site under the high Hertzian shear stresses below the running surface. The presence of such defects is sufficient to initiate fatigue even under optimal rail-wheel contact.</p>	
Appearance	
<p>May not be visible at the surface in early stages of development but sometimes plastic deformation of the weld repaired region can be indicative of sub-surface fatigue. Detectable only by close visual inspection</p>

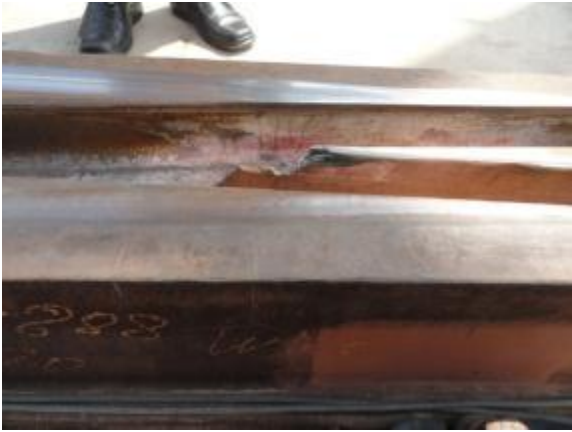
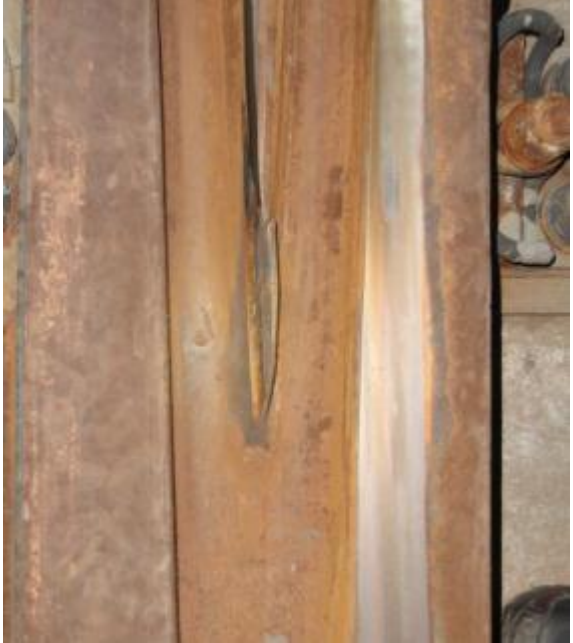
No. and Failure	Component
1.4.8 PLASTIC DEFORMATION OF THE CROSSING NOSE	Fixed crossing (cast manganese and built up)
Characteristics	
<p>This defect occurs only in turnouts with fixed crossings. It is characterised by bending and plastic yielding of the crossing because of the high lateral contact forces through non-optimal contact with the wheel.</p>	
<div style="display: flex; justify-content: space-around;">

</div>	
Possible Causes	
<ul style="list-style-type: none"> • Incorrect check rail gauge • Non-conformity of bogies (wheels) with S & C design • Incorrect geometry of previous weld repair (crossing nose too high, too thin or too much forward) 	
Appearance:	
<ul style="list-style-type: none"> • Crossing nose of fixed crossings bent or broken off 	
Corrective/Preventative Measures:	
<ul style="list-style-type: none"> • Check rail adjustment • Repair of crossing nose (welding, grinding) • Replacement of crossing

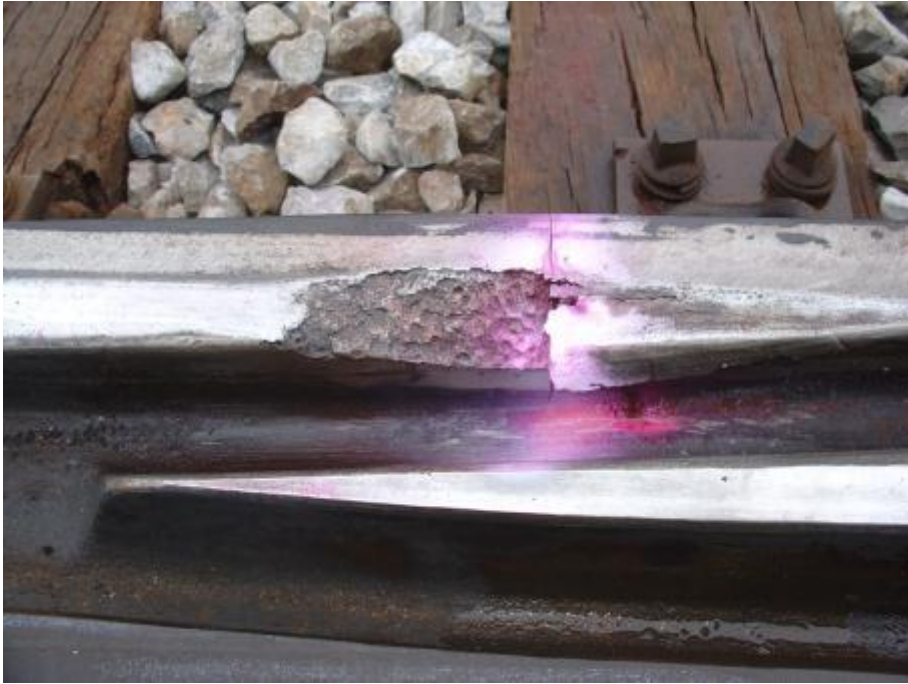
No. and Failure	Component
1.4.10 MATERIAL BREAK-OUTS ON MANGANESE CROSSINGS	Cast manganese crossings
Characteristics	
This defect is characterised by breaking-out of material out of a Manganese frog.

Possible Causes	
<ul style="list-style-type: none"> • High dynamic forces on material, fatigue damage Sub-surface porosity or casting defect that acts as the site of internal fatigue initiation – depending on the size of the defect, the sub-surface shear stresses arising from even optimal contact conditions can be sufficient to initiate and grow fatigue cracks. • Incorrect previous repair welding (temperature too high). 	
Appearance	
<ul style="list-style-type: none"> • Cast Manganese Crossings. 	
Corrective/Preventative Measures	
<ul style="list-style-type: none"> • Repair welding of crossing • Replacement of crossing. 	
Failure detection

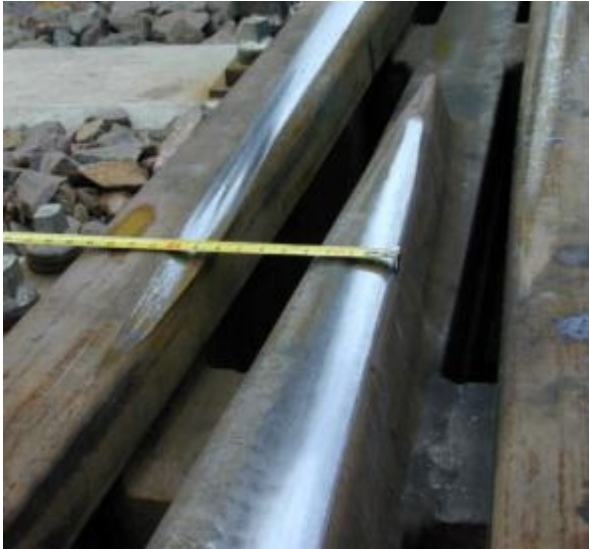
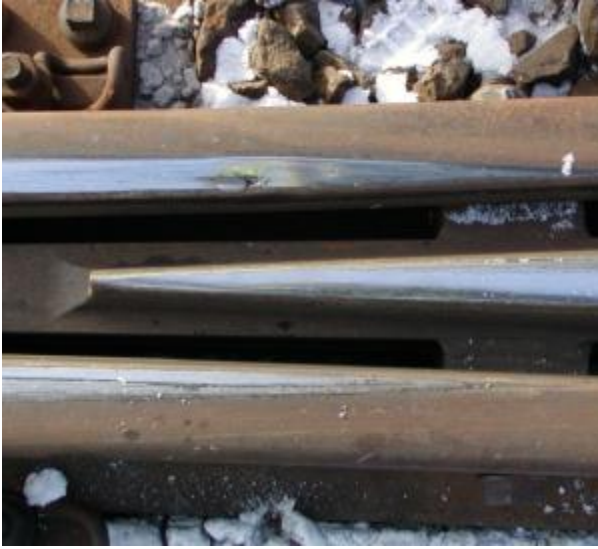
No. and Failure	Component
1.4.11 PLASTIC DEFORMATION OF WING RAIL	Fixed Crossings (cast manganese and built up)
Characteristics	
<p>This defect is characterised by a depression in the running surface and metal flow leading to the formation of burr on the inner side of the wing rail. This defect can lead to material breakouts and spalling (see also defect 1.4.11) of the running surface.</p>	
<div style="display: flex; justify-content: space-around;">

</div>	
Possible Causes	
<ul style="list-style-type: none"> • Stresses exceeding yield strength caused by high dynamic forces on material due to non-optimal wheel transfer zone • Wheel flange not matching together with design of wheel transfer zone • Inadequate control of wheel profile 	
Appearance	
<ul style="list-style-type: none"> • On wing rails in the zone of the wheel transfer 	
Corrective/Preventative Measures	
<ul style="list-style-type: none"> • Deburring • Resurfacing by build-up welding (if necessary) • Explosion depth hardening for cast manganese crossings

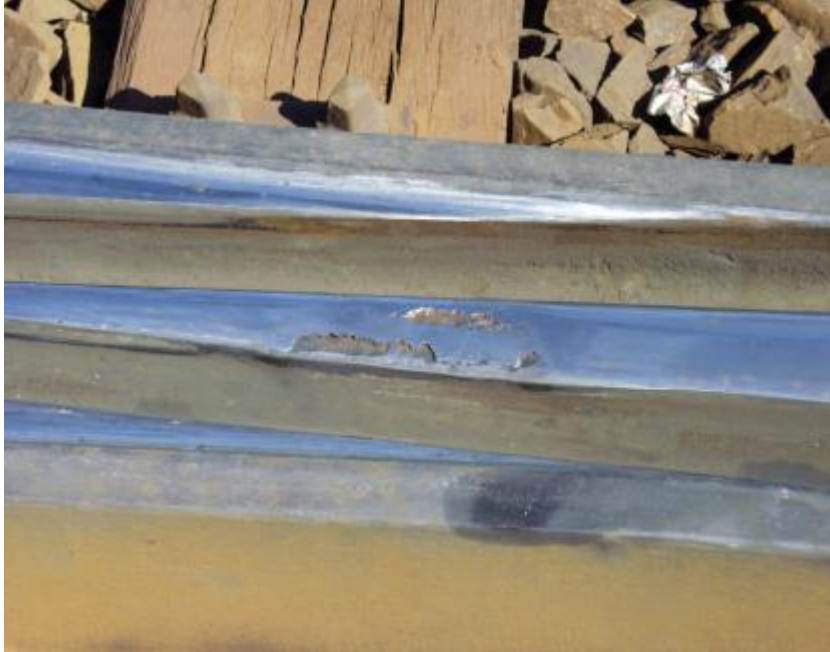
No. and Failure	Component
1.4.12 SPALLING OF CROSSINGS	Fixed Crossings (cast manganese and built up)
Characteristics	
<p>This defect mainly occurs in the wheel transfer area of the crossing nose/wing rail. In a pre-stadium the defect is characterised especially on the wing rail as a longitudinal crack below the running gauge.</p>

Possible Causes	
<ul style="list-style-type: none"> • High dynamic forces leading to sub-surface initiation of fatigue cracks and subsequent merging of cracks to cause spalling. High dynamic forces are likely to result from non-optimal wheel transfer zone and poor support conditions • Wheel flange not matching together with design of wheel transfer zone • Inadequate control of wheel profile 	
Appearance	
<ul style="list-style-type: none"> • In the wheel transfer area of the crossing nose/wing rail 	
Corrective/Preventative Measures	
<ul style="list-style-type: none"> • Deburring • Repair welding mostly extensive (especially on the wing rail) • Replacement of the crossing • Adherence to the control limits on wheel profile
