Capacity for Rail

Operational failure modes of Switches and Crossings

Public deliverable D 1.3.1

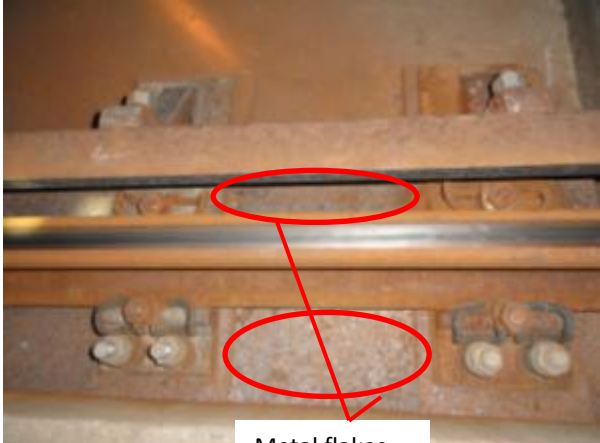
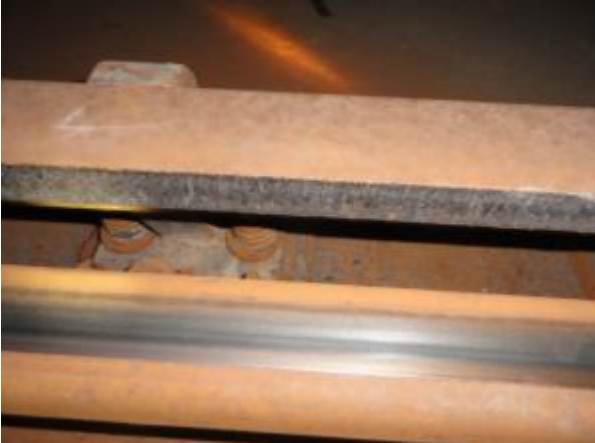
No. and Failure	Component
1.5.1 EXCESSIVE WEAR ON CHECK RAILS	Check Rail
Characteristics	
<p>This defect is characterized by excessive wear on the thread bearing side surface of the check rail. A typical wear pattern can be seen together with fine metal flakes in the surrounding of the check rail. When this defect is not corrected, the check gauge is corrupted, which leads to damage on the crossing point (bent point, breaking out of point) and is safety critical.</p>	
<div style="display: flex; justify-content: space-around;">

</div>	
Possible Causes	
<ul style="list-style-type: none"> • Too stiff bogies with low self-steering properties. • Too narrow check rail gap. • Too high train speed in diverging direction. • Accelerating train in diverging direction. 	
Appearance	
<ul style="list-style-type: none"> • Check rails 	
Corrective/Preventative Measures	
<ul style="list-style-type: none"> • Re-adjust check gauge with shims. • Replace check rail. • Choose check rail of higher steel grade. • Vehicle maintenance

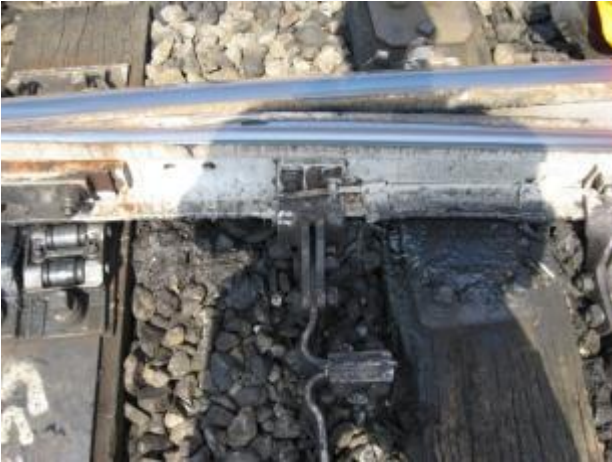
No. and Failure	Component
1.6.1 CONTAMINATION / EXCESSIVE WEAR OF SLIDE PLATES/SLIDING INSERTS OR ROLLER SYSTEMS	Slide plates, sliding inserts, roller systems of switch & stock rail assembly respectively moveable crossings
Characteristics	
This defect is characterised by contamination or excessive wear of slide plates respectively the sliding inserts or roller systems. The defect may lead to setting problems of S & C.

Possible Causes	
<ul style="list-style-type: none"> • Incorrect maintenance • Incorrect adjustment of roller systems 	
Appearance	
<ul style="list-style-type: none"> • Slide plates 	
Corrective/Preventative Measures	
<ul style="list-style-type: none"> • Cleaning of slide surface • Proper lubrication respectively adjustment of roller systems • Replacement of sliding inserts / slide plates 	
Failure detection	
<ul style="list-style-type: none"> • by visual inspection

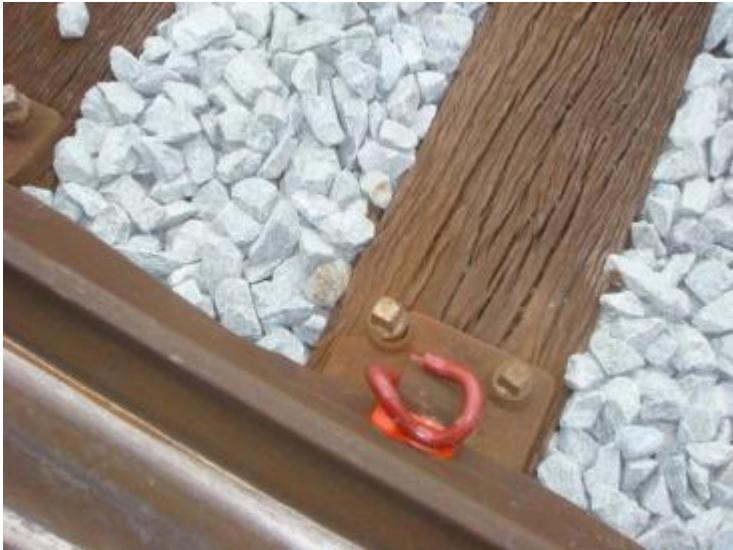
No. and Failure	Component
1.6.2 BREAK OF PLATES / CHECK RAIL CHAIR	Plate, check rail chair
Characteristics	
<p>This defect is characterised by a structural break of baseplates (common baseplates/ slide baseplates / check rail supports).</p> <p>The defect may lead to failure propagation (high tensile forces on adjacent components) and can lead to a critical failure in the case of multi-failures.</p>

Possible Causes	
<ul style="list-style-type: none"> • High dynamic forces on material due to insufficient support stiffness • Incorrect adjustment of check rail gauge (flangeway clearance) 	
Appearance	
<ul style="list-style-type: none"> • Broken plates and chairs 	
Corrective/Preventative Measures	
<ul style="list-style-type: none"> • Adjustment of check rail gauge • Redundancy of elements • Replacement of components 	
Failure detection	
<ul style="list-style-type: none"> • by visual inspection

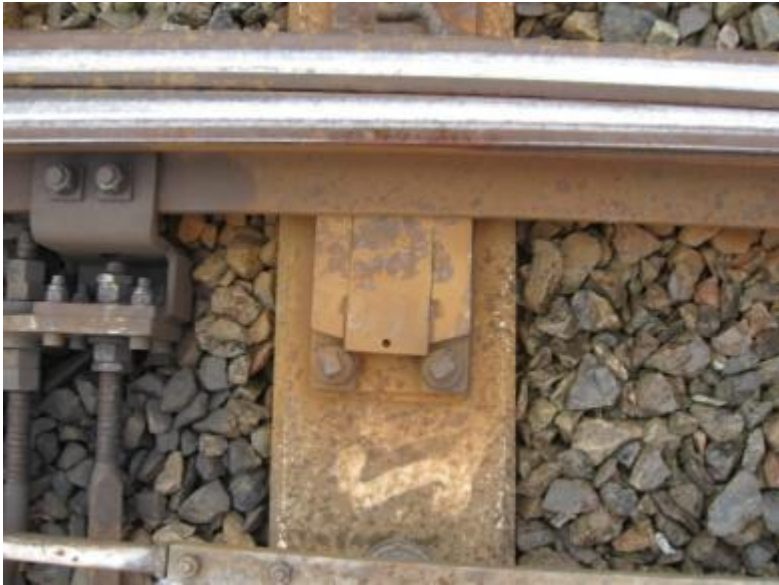
No. and Failure	Component
1.6.3 SLITE PLATE INSERT (PIN) FAILURE	Slide baseplates
Characteristics	
<p>This defect is characterised by a loosening or breaking of the retaining pins on slide baseplate inserts. The defect may lead to failure of switch operation and subsequently detection of point operation equipment.</p>

Possible Causes	
<ul style="list-style-type: none"> • High dynamic forces on material • Inappropriate design for local conditions • Incorrect adjustment of check rail gauge (flangeway clearance) 	
Appearance	
<ul style="list-style-type: none"> • Broken / missing retaining pins • Slide insert loose or missing 	
Corrective/Preventative Measures	
<ul style="list-style-type: none"> • Replacement of components 	
Failure detection	
<ul style="list-style-type: none"> • by visual inspection

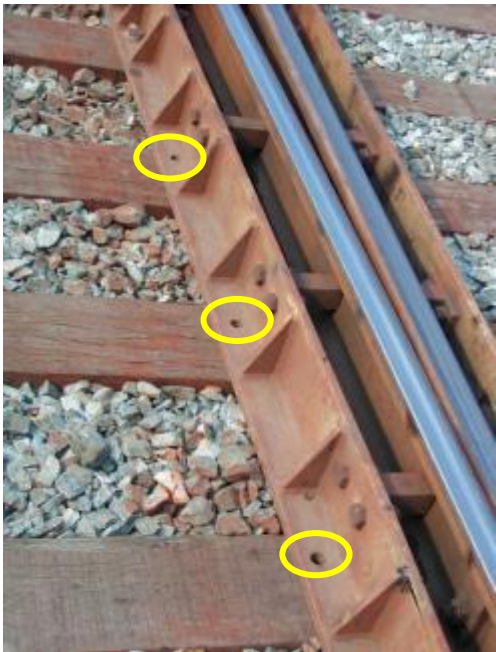
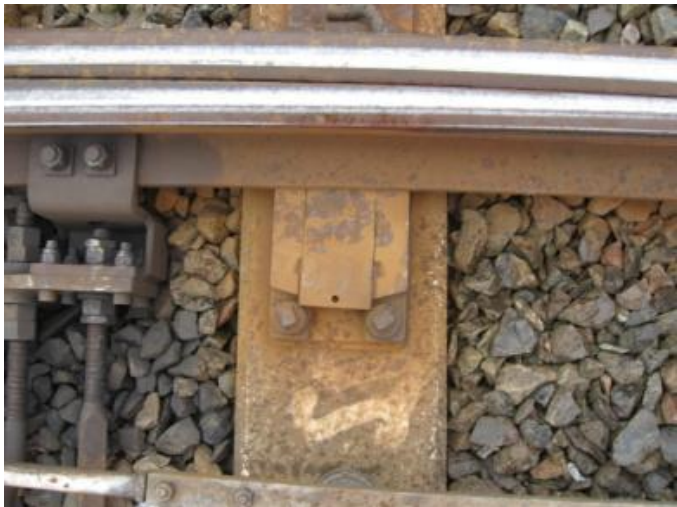
No. and Failure	Component
1.7.1 BREAK/LOOSENING OF FASTENING ELEMENTS	Fastening elements in a S&C
Characteristics	
<p>This defect is characterised by a loosening/loss of fastening elements in S&Cs.</p> <p>The defect may subject other adjacent components to increased stresses and vibration and eventually to their failure.</p> <div style="display: flex; justify-content: space-around;">

</div>	
Possible Causes	
<ul style="list-style-type: none"> • High dynamic forces/vibrations on material due to insufficient support stiffness • Incorrect fastening 	
Appearance	
<ul style="list-style-type: none"> • All fastening elements in a S & C 	
Corrective/Preventative Measures	
<ul style="list-style-type: none"> • Inspection procedures • Redundancy of fastening elements • Refastening of elements 	
Failure detection	
<ul style="list-style-type: none"> • by visual inspection

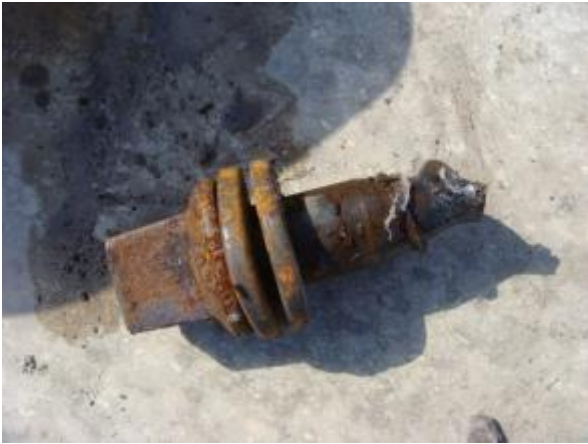
No. and Failure	Component
1.7.2 BROKEN BOLTS / SCREWS	Crossing Bolts / Switch Bolts / Multiple Groove Locking Pins
Characteristics	
<p>This defect is characterised by a by Broken Bolts in the switch and crossing assemblies</p> <p>This can lead to baseplates and blocks becoming loose and obstructing either rail vehicles or the movement of the switch</p> <div style="display: flex; align-items: flex-start;">

<ul style="list-style-type: none"> • Heel block bolts • Crossing Bolts • Fishbolts • Switch slide bolts • Switch Spacer bolts • Check Rail Bolts • Switch Chair screws </div>	
Possible Causes	
<ul style="list-style-type: none"> • High dynamic forces/vibrations on material due to insufficient support stiffness • Poor track maintenance, incorrect torque applied to nuts • Localised environmental conditions leading to corrosion of components 	
Appearance	
<ul style="list-style-type: none"> • Broken Bolts, missing nuts and washers • Loose / missing cast items

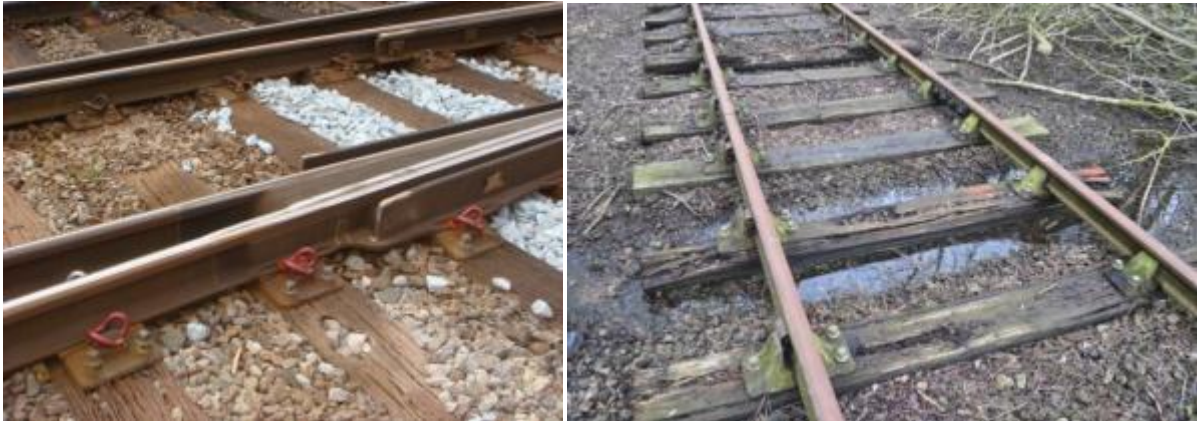
No. and Failure	Component
1.8.1 ROTEN / BROKEN TIMBER BEARERS	Timber bearers
Characteristics	
<p>This defect is characterised by a defect in the timber bearer which may lead to inability of the bearer to support the track system.</p> <p>It can lead to baseplate screws becoming loose and premature failure of cast baseplates and subsequent failure of other system components.</p> <p>Switch detection can also be affected as backdrive mounting plates become loose.</p>

Possible Causes	
<ul style="list-style-type: none"> • High dynamic loads • Deterioration of timber integrity because of poor local environment e.g. poor drainage. • Incorrect track drainage • Poor Track Maintenance • Aging 	
Appearance	
<ul style="list-style-type: none"> • Loose Baseplate Screws • Missing sections of timber 	
Corrective/Preventative Measures	
<ul style="list-style-type: none"> • Replace defective bearer 	
Failure detection

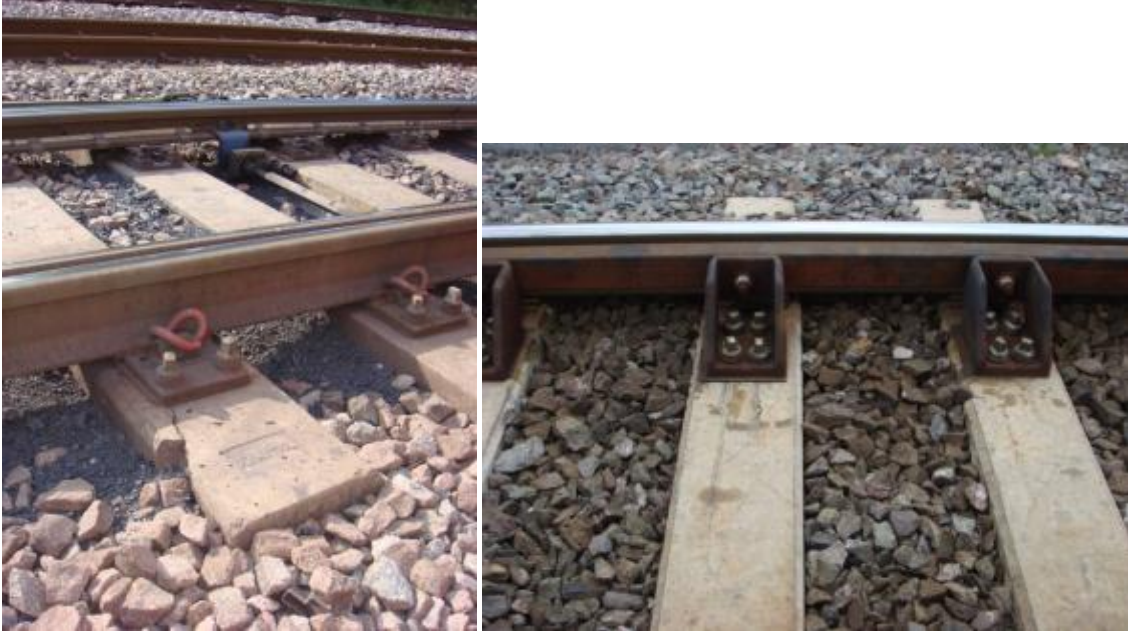
No. and Failure	Component
1.8.2 CRACKED / BROKEN CONCRETE BEARERS	Concrete bearers
Characteristics	
<p>This defect is characterised by a defect in the concrete bearer which may lead to inability of the bearer to support the track system. It can lead to baseplate screws becoming loose and premature failure of cast baseplates and subsequent failure of other system components.</p>	
<p>Switch detection can also be affected.</p>

Possible Causes	
<ul style="list-style-type: none"> • High dynamic loads • Inconsistent support conditions in vicinity of sleepers/bearers • Incorrect mix design of concrete or poor installation of components • Foreign obstacle in screw holes when tightening (before installation or during maintenance) • Poor Track Maintenance 	
Appearance	
<ul style="list-style-type: none"> • Loose Baseplate Screws • Missing sections of concrete, exposed pre-stressing wires, longitudinal cracks

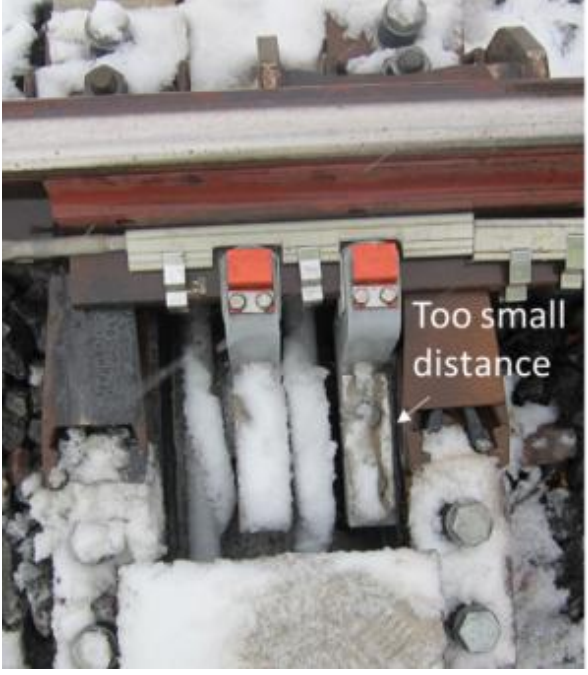
No. and Failure	Component
1.8.3 MISALIGNED BEARERS	Concrete bearers / sleepers
Characteristics

<p>The bearer is moved longitudinal either by forces in the ballast layer or at tamping operation.</p> <p>The distance between the baseplates changes and therefore the rail is no longer supported in a correct way. It will lead to higher stresses in some parts of the rail and higher dynamic loads of the whole system.</p> <p>Switch rods may also come in conflict with the bearer leading to difficulties to move the switch blades.</p> <p><i>Pictures from Trafikverket</i></p>
Possible Causes	
<ul style="list-style-type: none"> • Longitudinal loads in the ballast • S&C moving longitudinal • Lack of ballast between bearer • Incorrect Track Maintenance 	
Appearance	
<ul style="list-style-type: none"> • Misaligned bearer • Bearer in contact with rods 	
Corrective/Preventative Measures	
<ul style="list-style-type: none"> • Reposition bearer

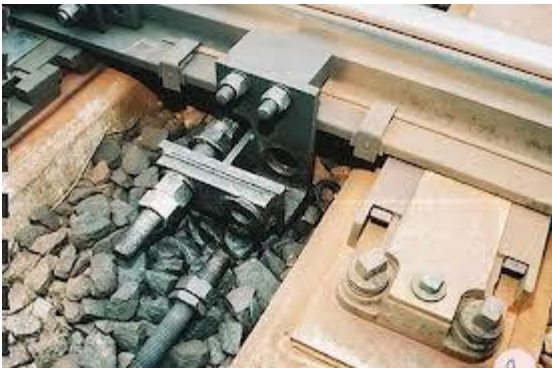
No. and Failure	Component
1.9.1 BREAKAGE OF STRETCHER BAR JOINT	Stretcher bar
Characteristics	
<p>This defect is characterised by a breakage of the stretcher bar. This can occur in one or a combination of areas depending on the design of the stretcher bar and frequency of use.</p> <div style="display: flex; align-items: flex-start;">

<div style="margin-left: 20px;"> <p>In addition to failures in the actual bar (for example 'goose neck' and 'ear' failures) it can be resulting from missing or loose bolts.</p> <p>This can lead to critical failures of the S&C system.</p> </div> </div>	
Possible Causes	
<ul style="list-style-type: none"> • Poor maintenance leading to increased dynamic loads and vibrations • Excessive switch operation forces • Wheel flange back contact 	
Appearance	
<ul style="list-style-type: none"> • Cracks evident in Stretcher bars components • Loose / missing parts 	
Corrective/Preventative Measures

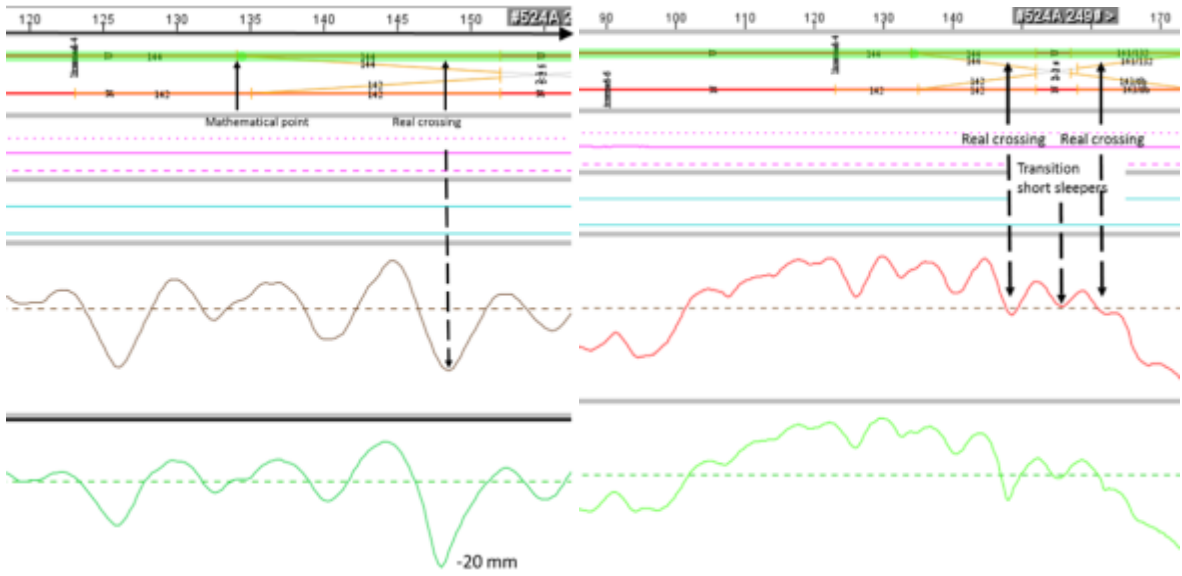
No. and Failure	Component
1.10.2 LARGE VARIATION OF TRACK POSITION IN CROSSING PANEL	Ballast bed
Characteristics	
<p>This defect occurs after certain traffic load and depends on uneven bed modulus and imperfect tamping due to difficulties to tamp where the sleepers are long. The dynamic forces are higher in this area as the wheel transfer between wing rail and stock rail induce dynamic forces. The larger area of the longer sleepers also typically results that they do not sink as fast as the ordinary sleepers behind the crossing panel, leading to height differences in the transition.</p>

<p>In the figure is shown short wave filtering (1-25 m) and unfiltered (1-150 m). Short wave is most important for the dynamic forces. Longer wavelengths show the difficulties of tamping without good height references. In this case the left S&C is tamped more often so it is higher than the right one.</p>
